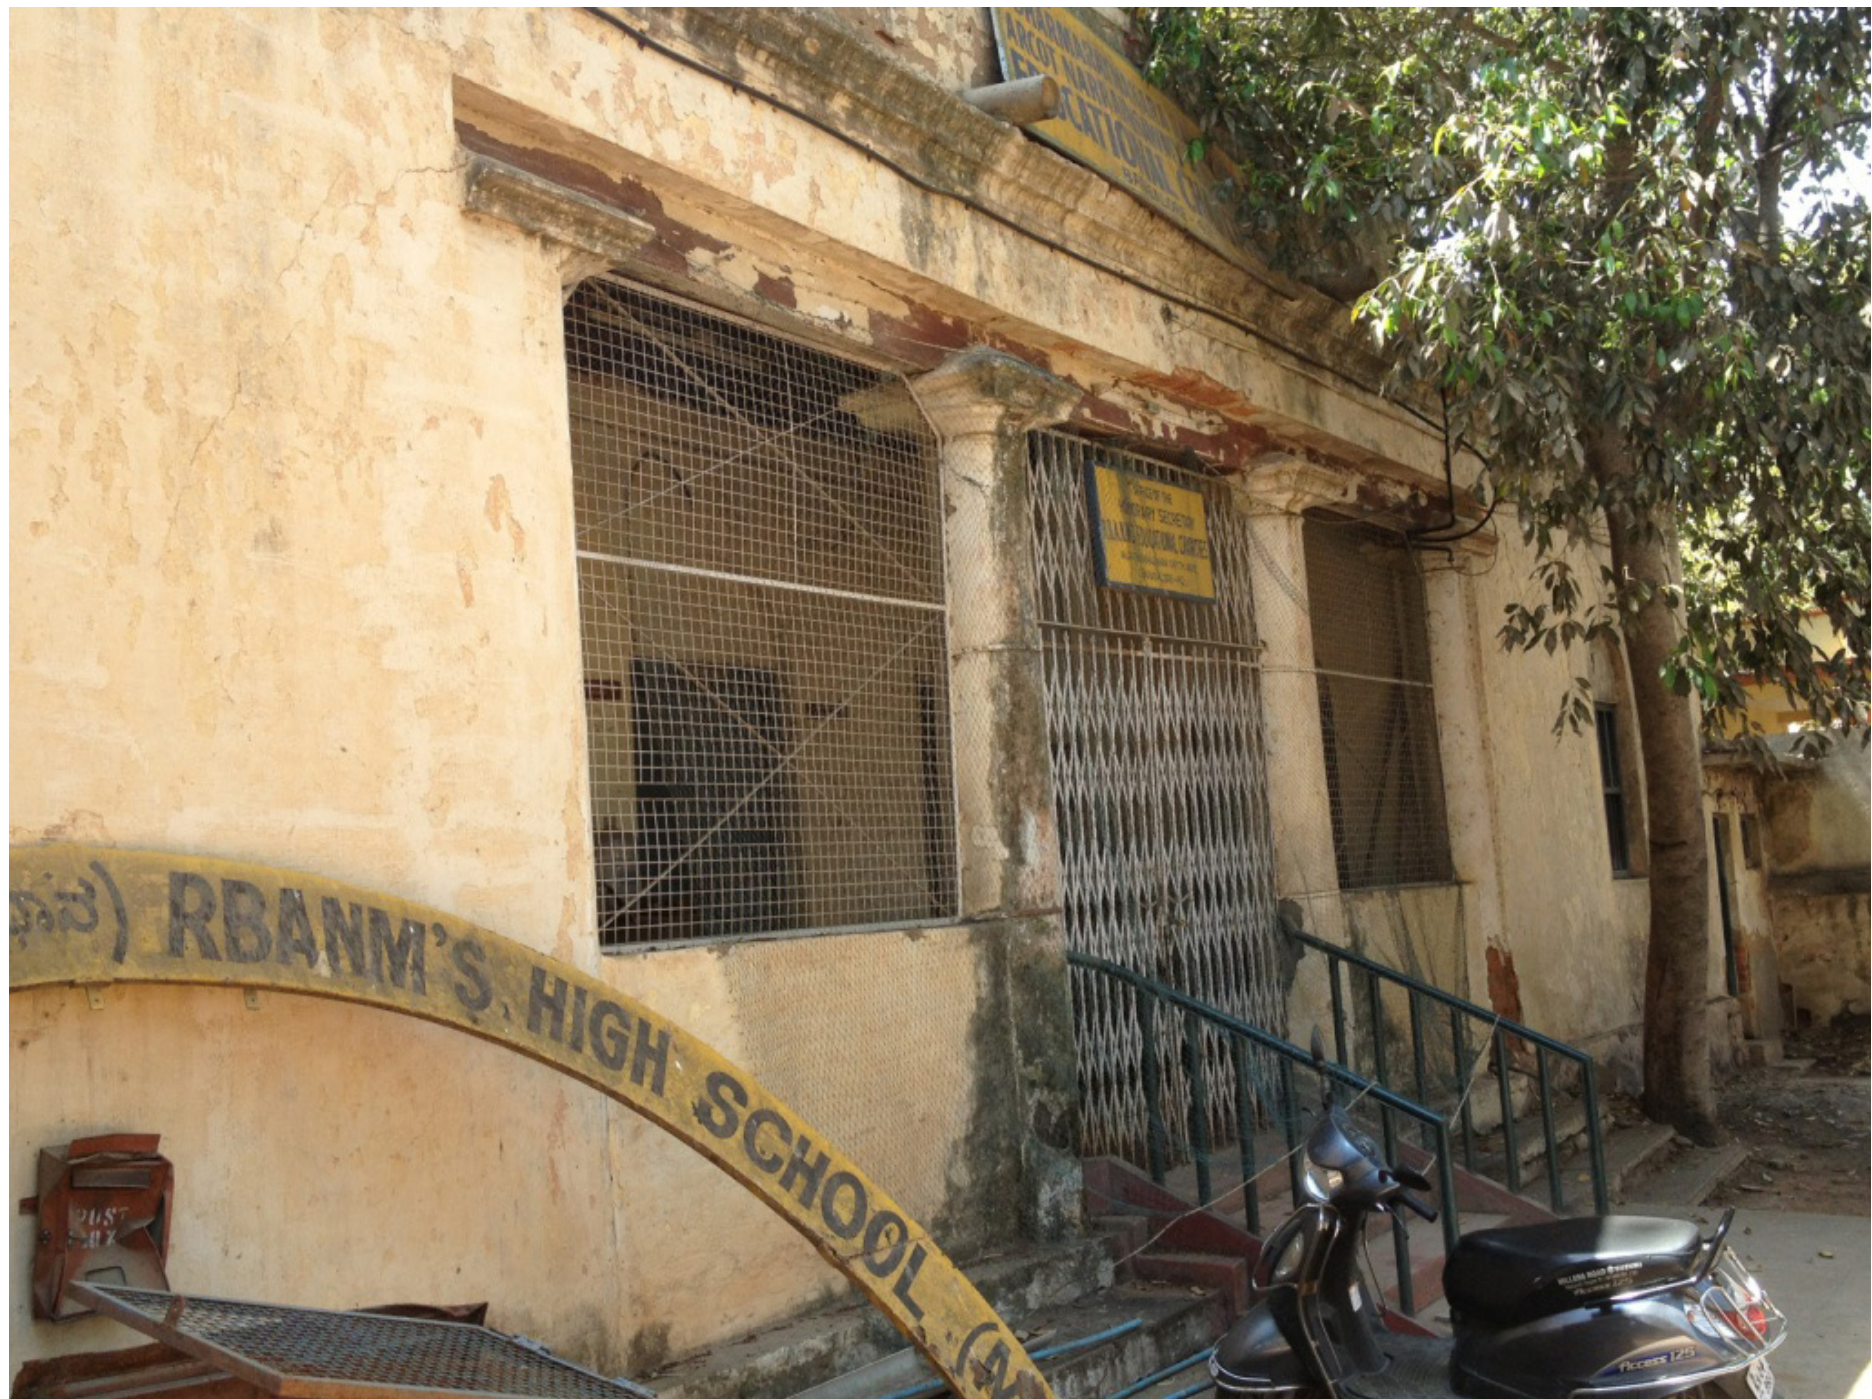
Exterior View - Entrance of the building earlier.

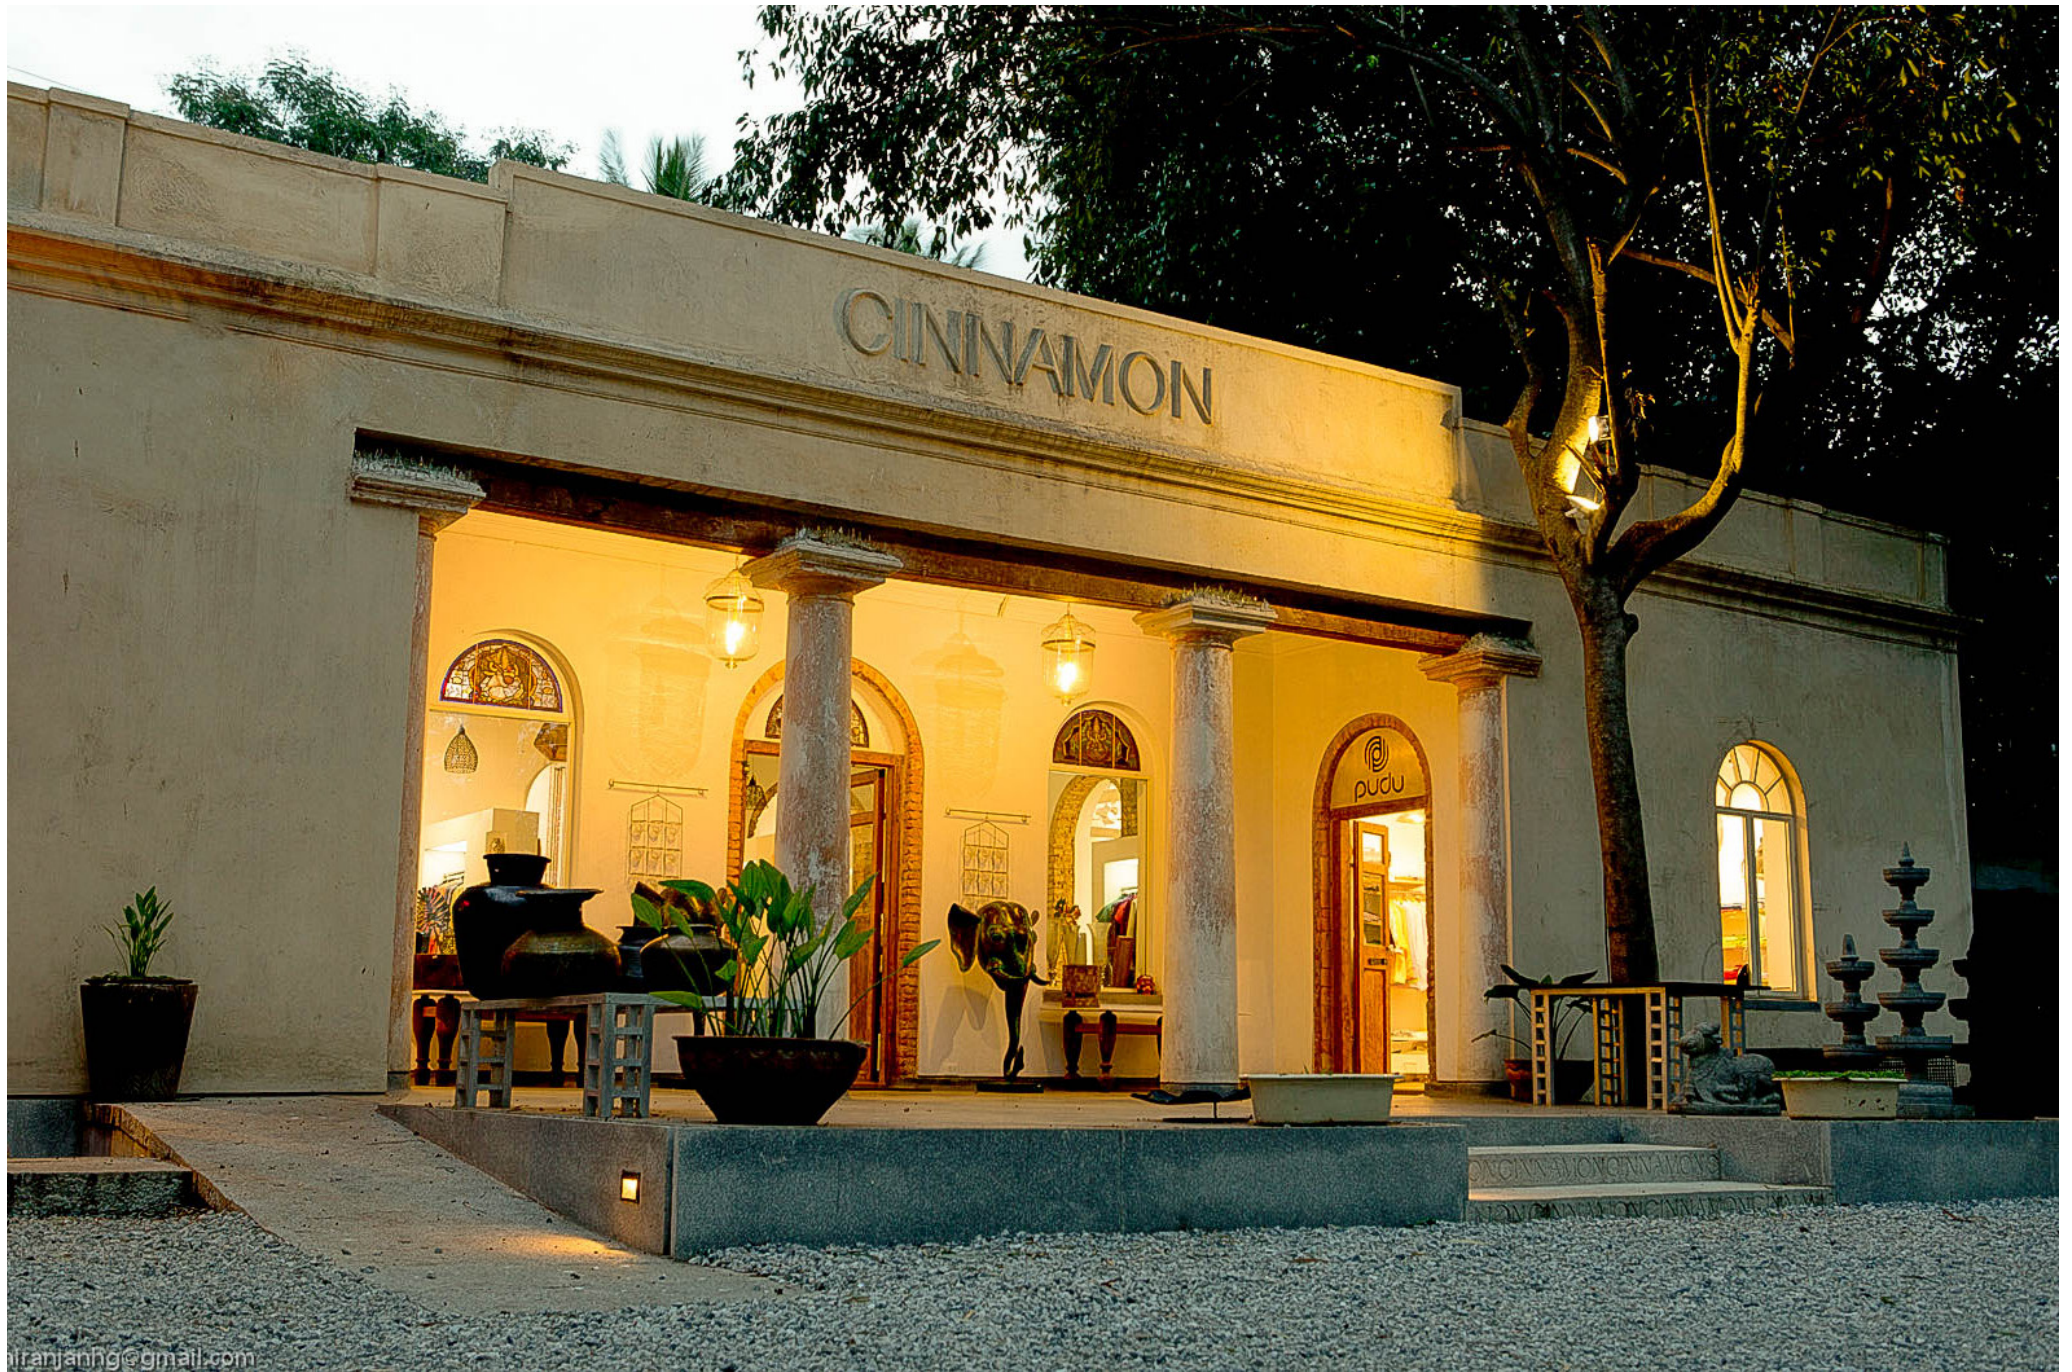
Exterior View - Entrance of the building now marked by a pebbled court.

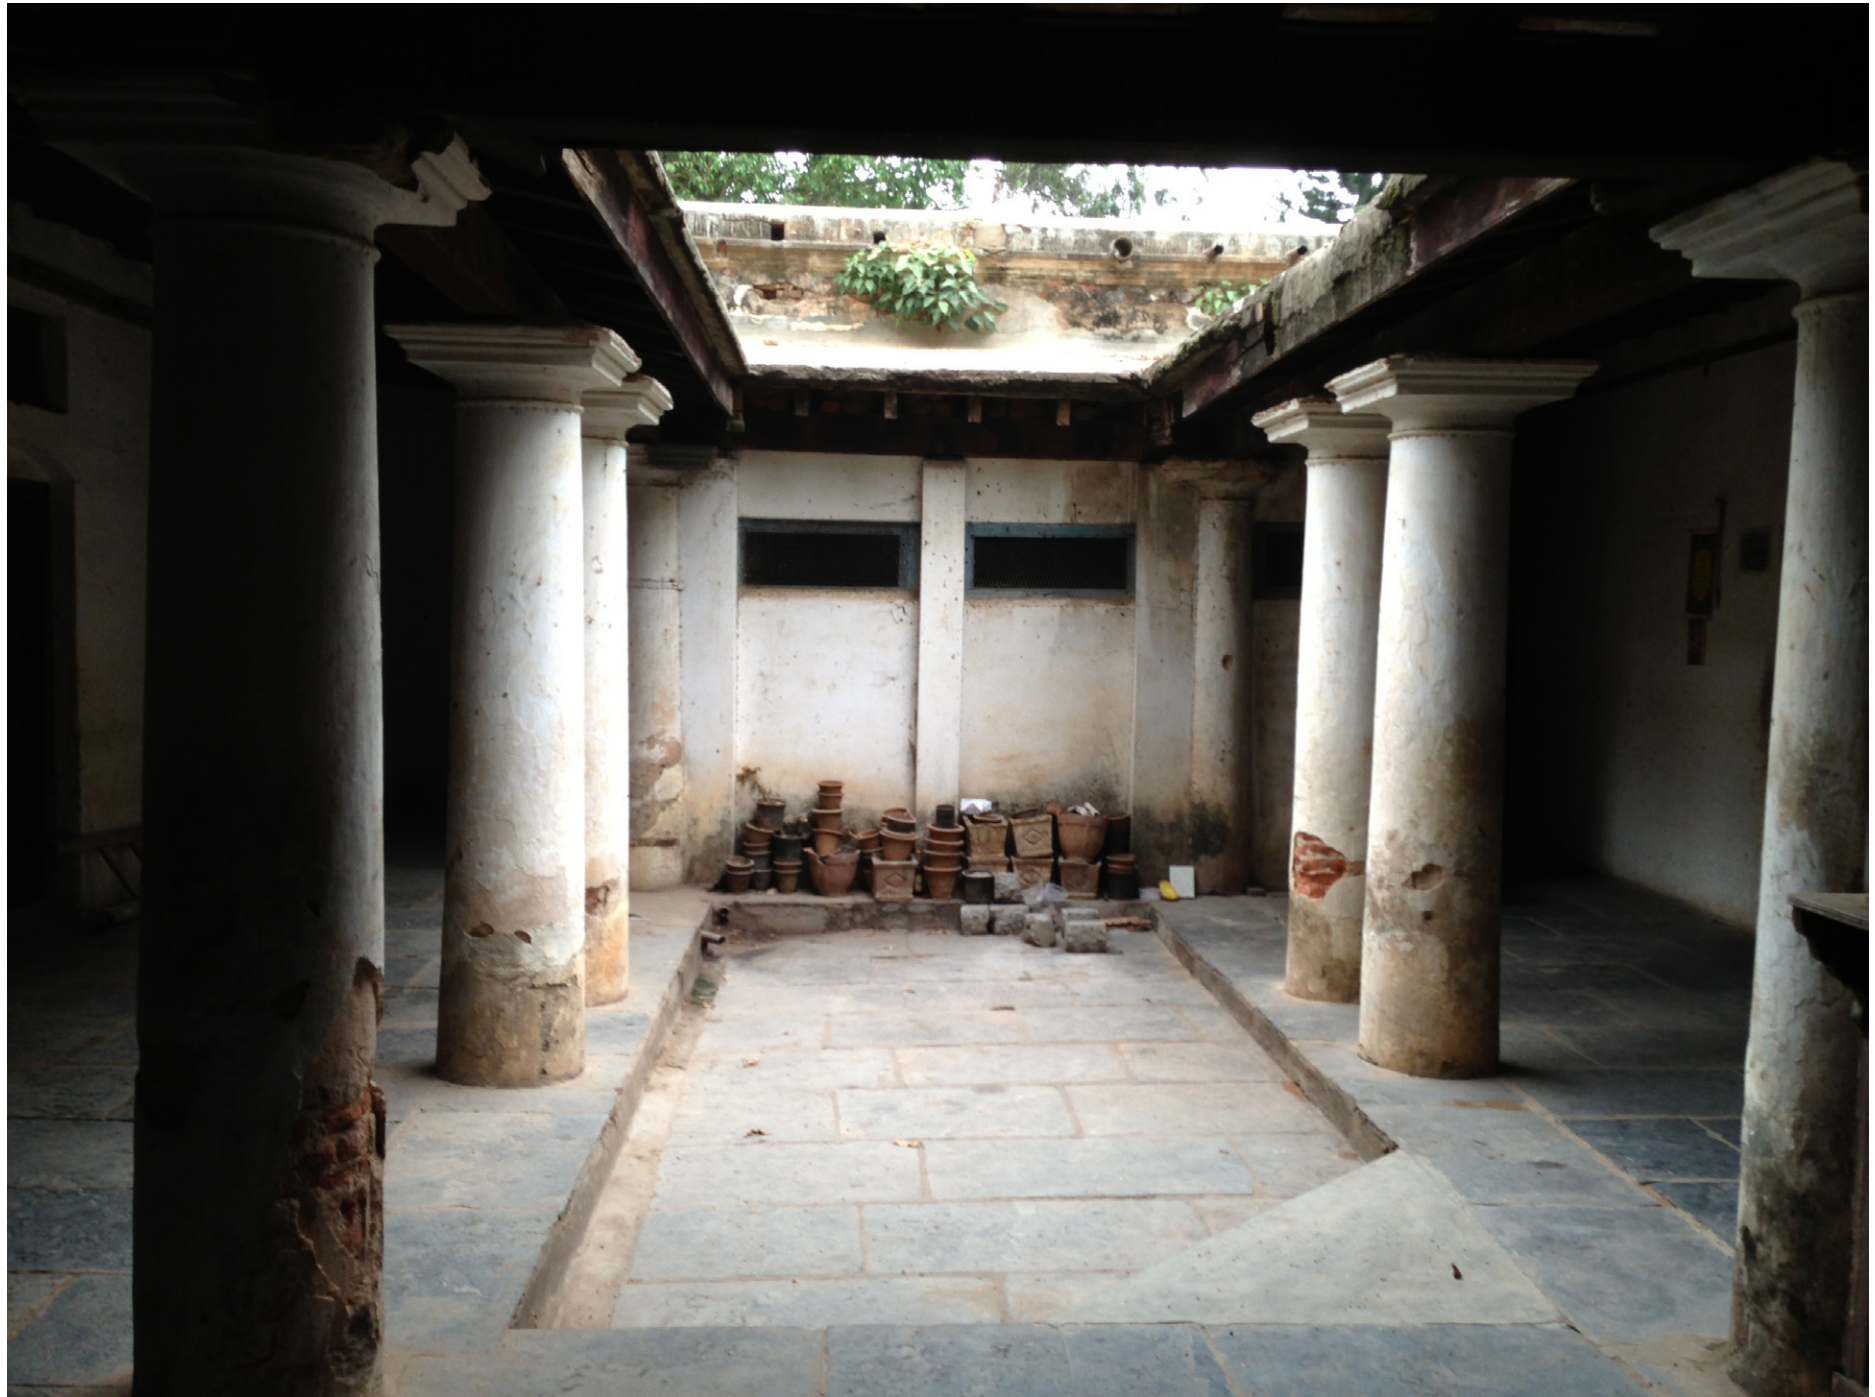
Interior view - View of courtyard as existed.

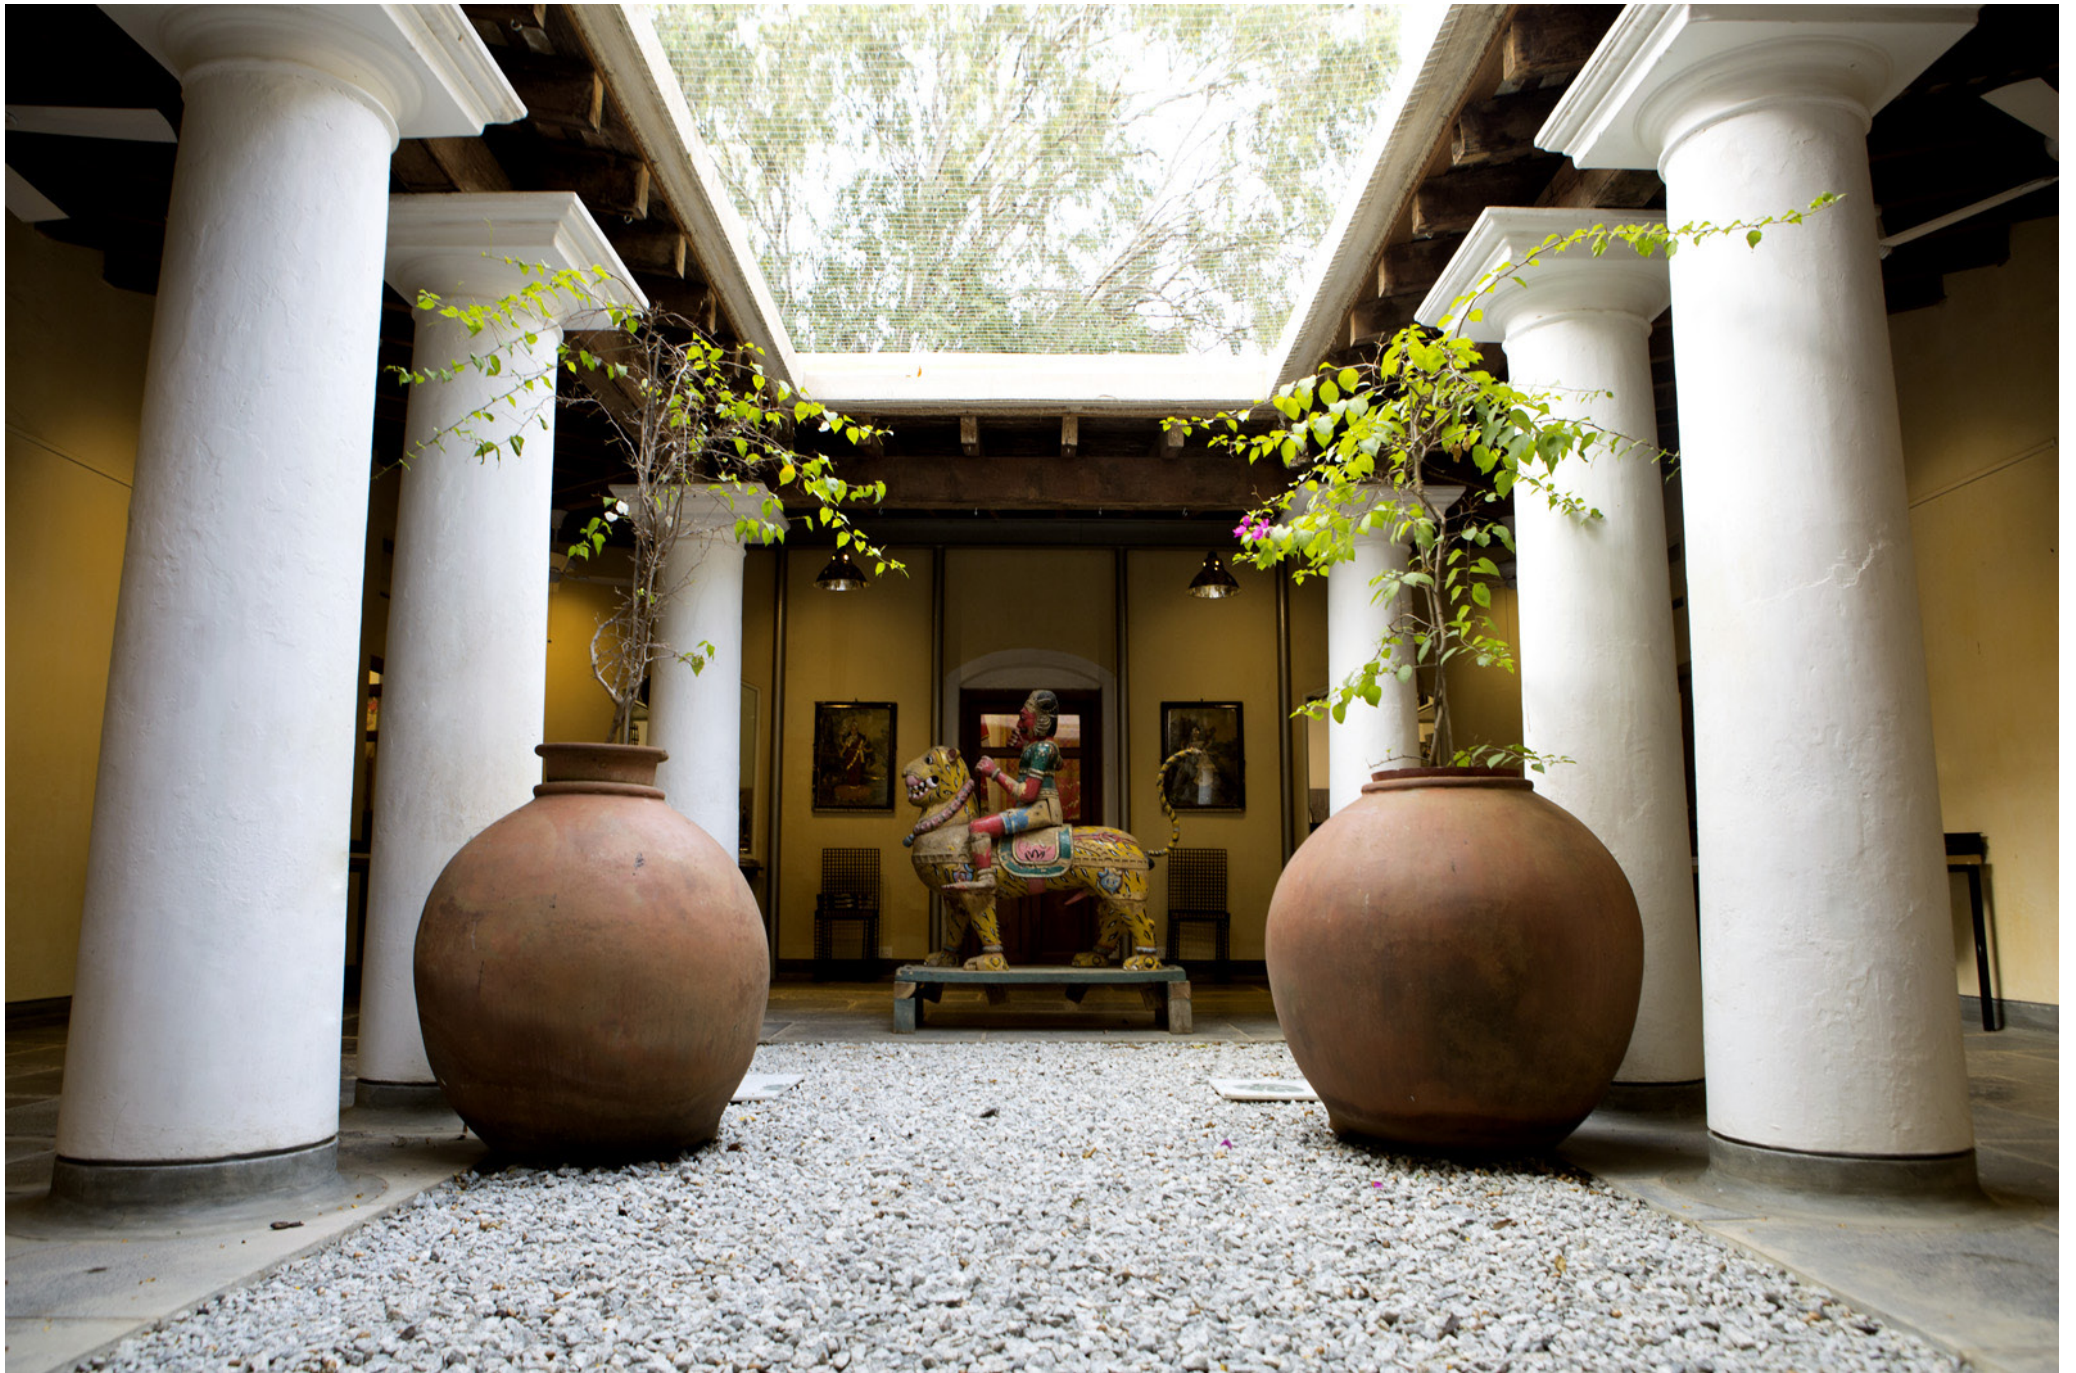
The central court now.

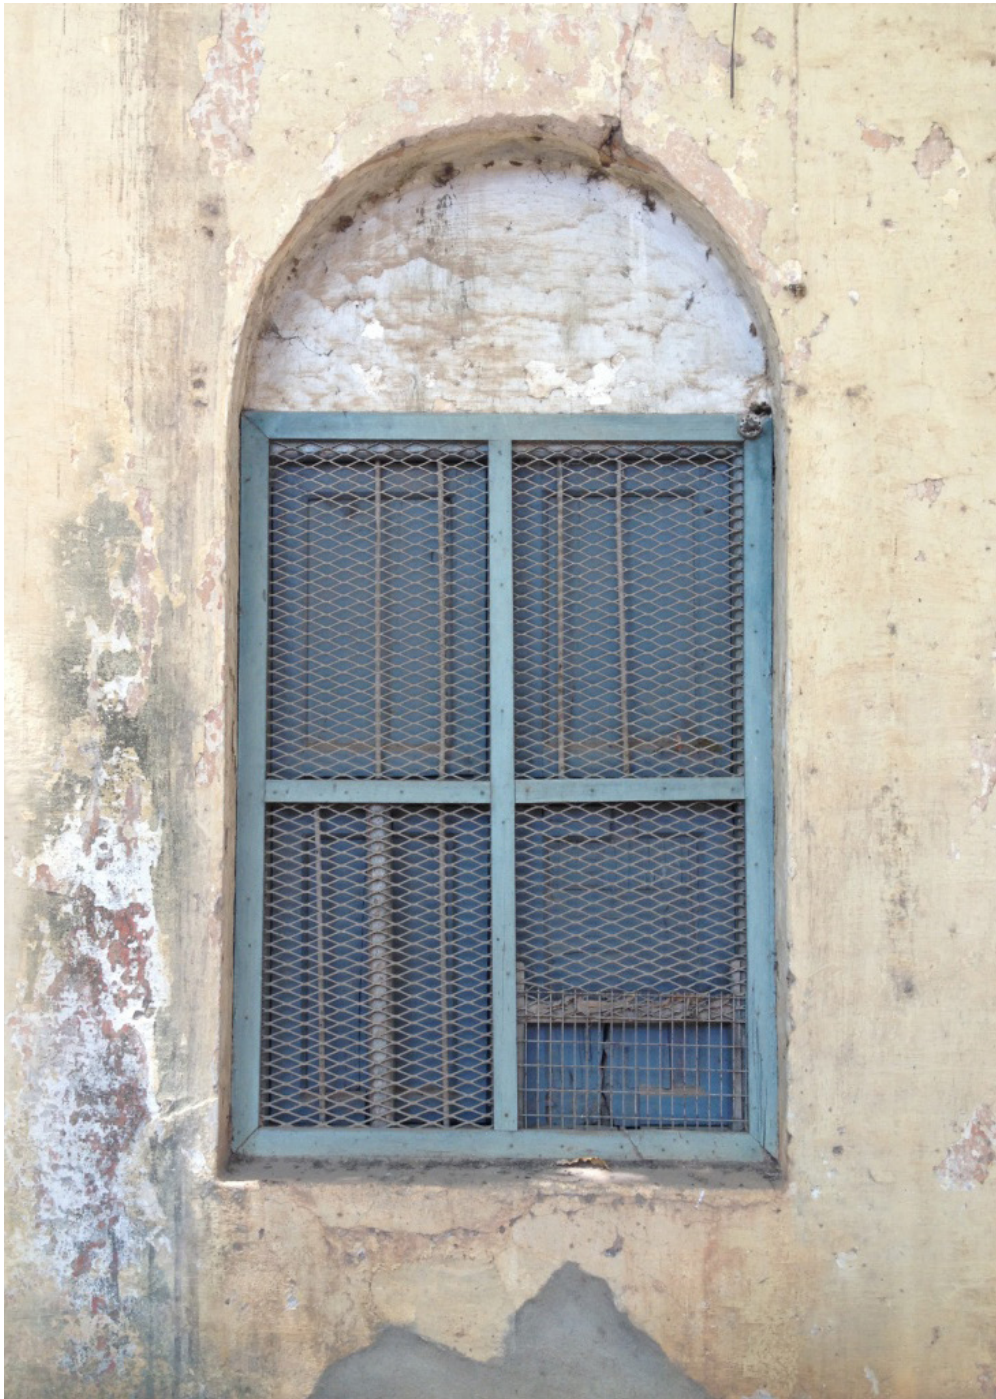
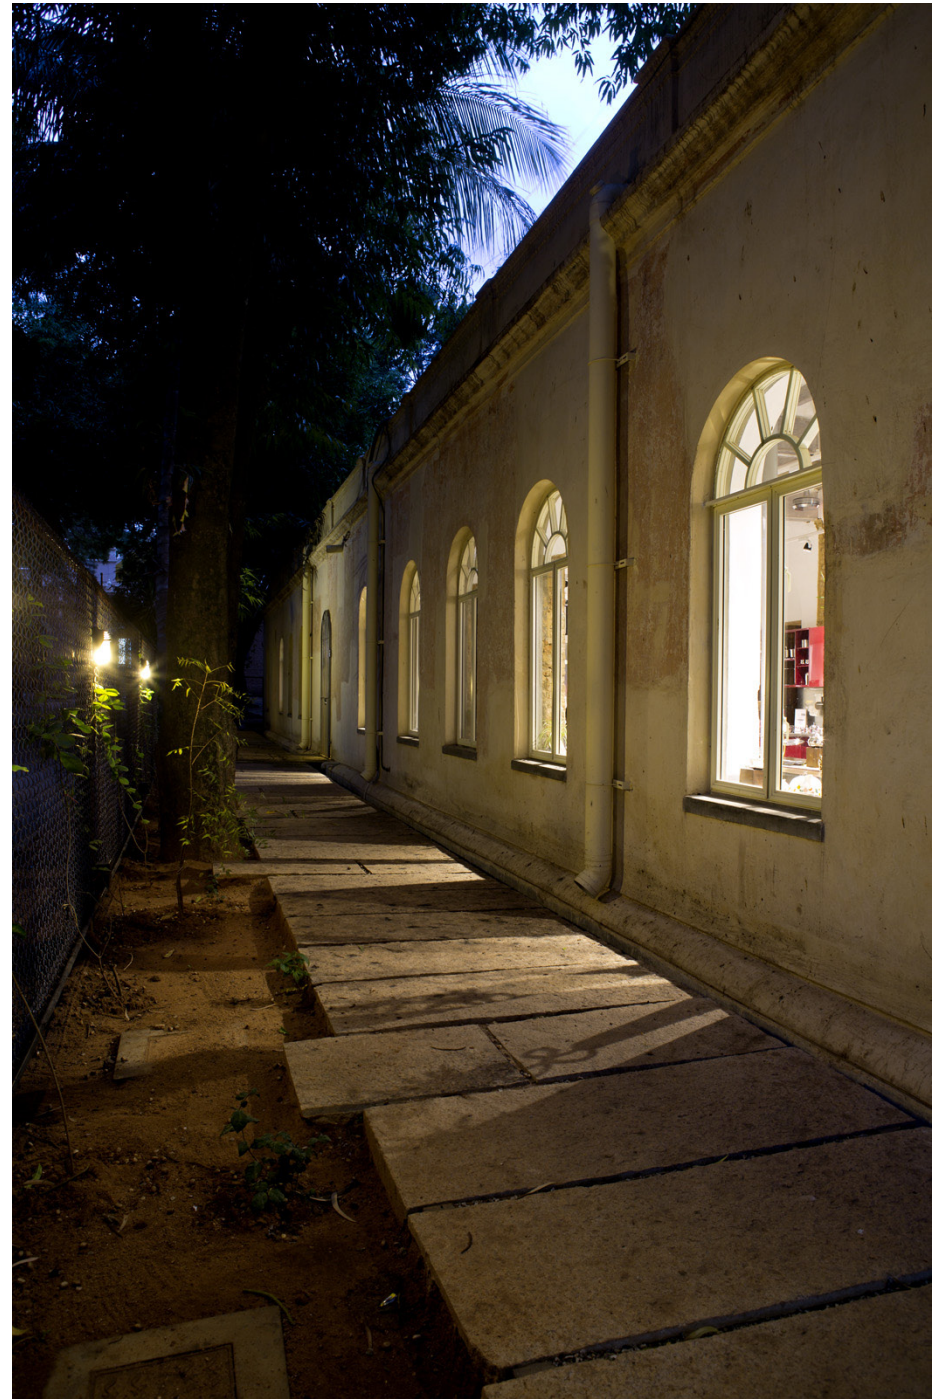
Window module as existing (left) and now restored (right).

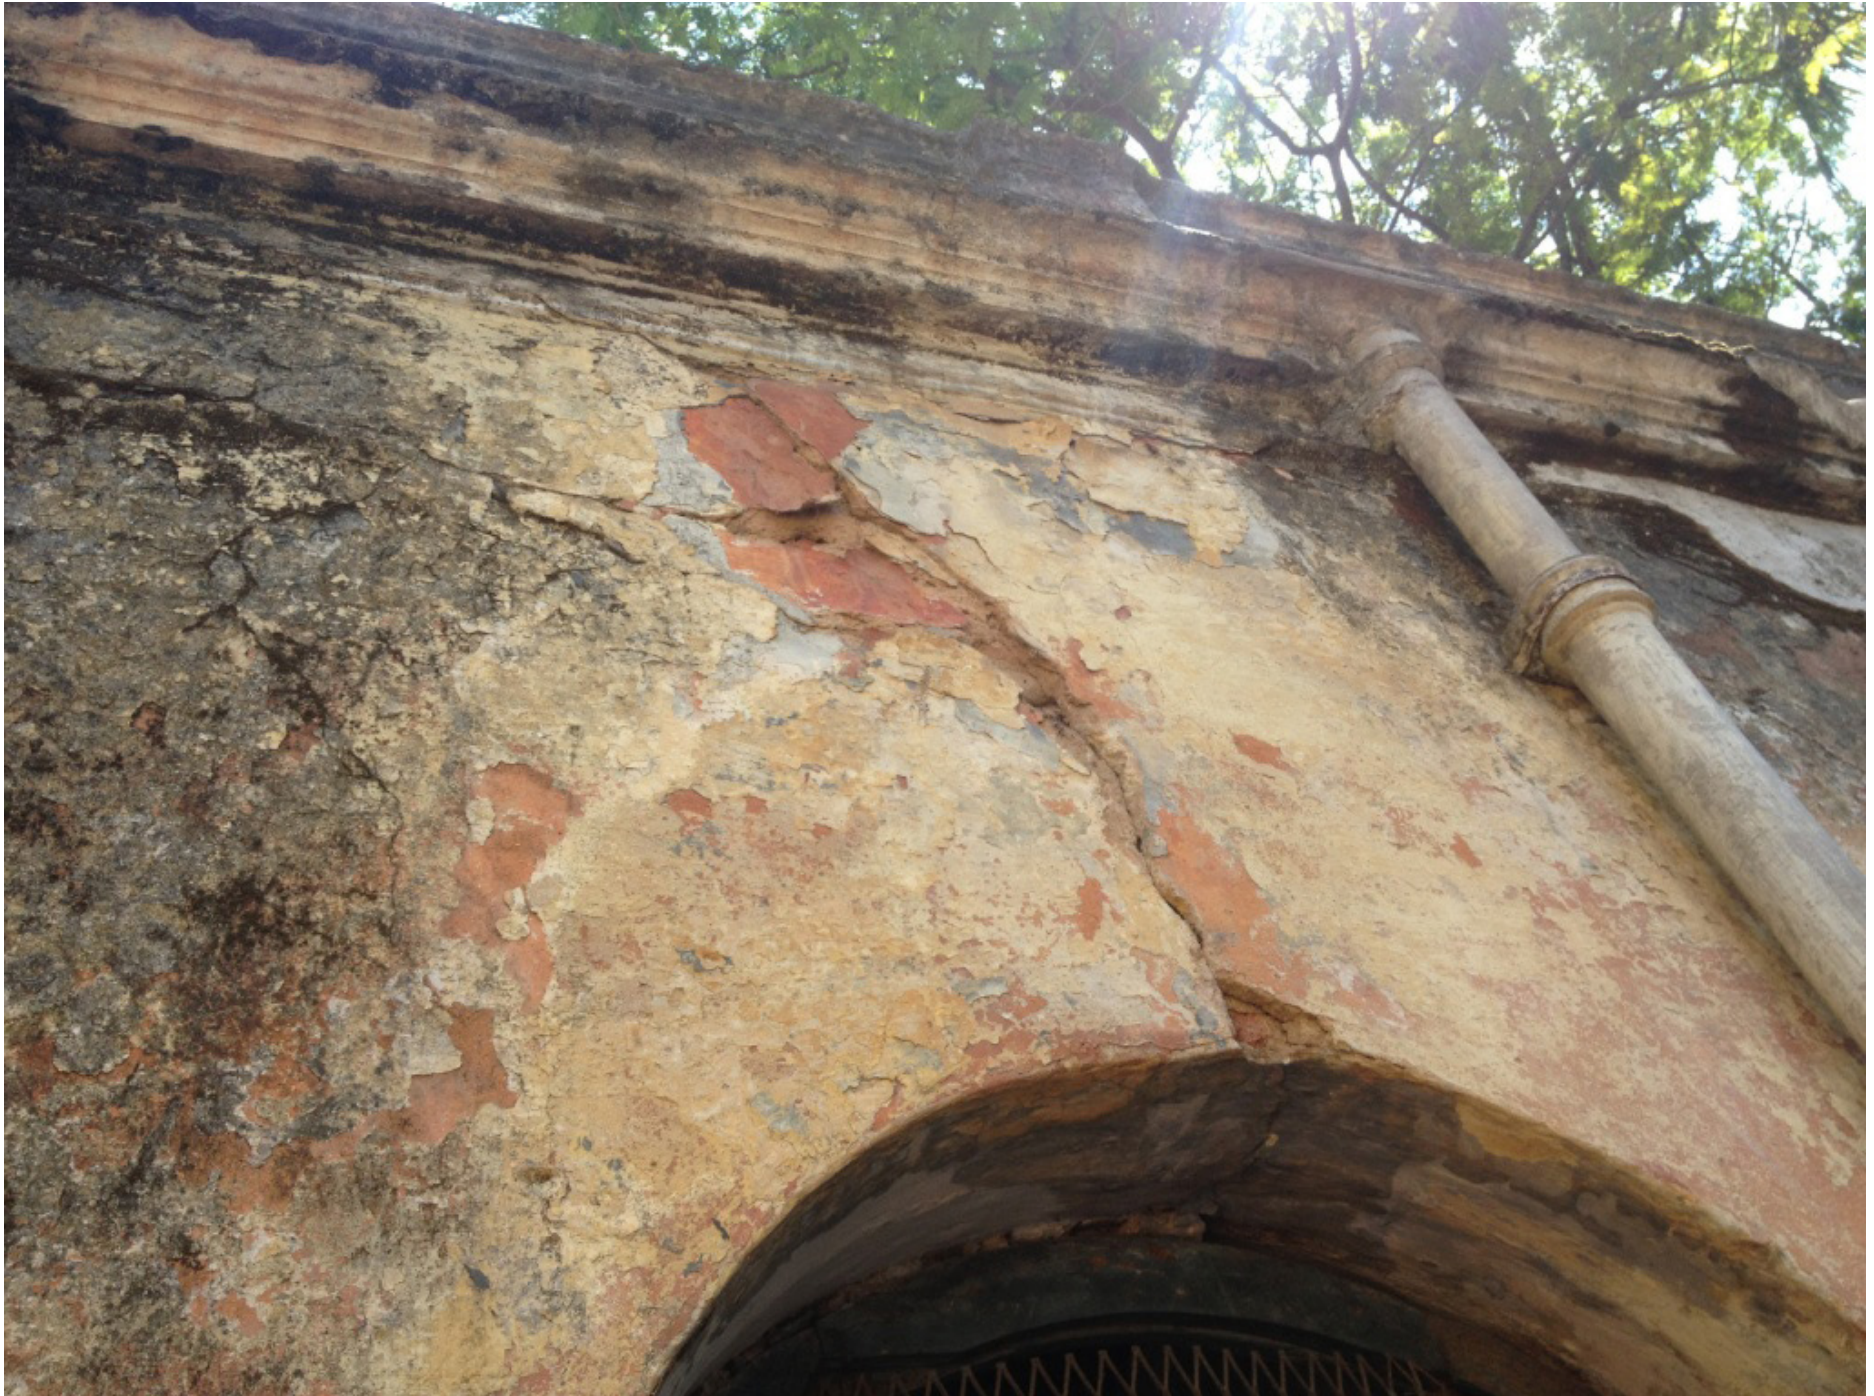
Structural cracks in the arch, now revived.
