**EXPERT COMMITTEE REPORT ON COLLAPSE OF
CANTILEVER PORTION OF COMMERCIAL BUILDING
AT SAMPIGE ROAD, MALLESWARAM,
BENGALURU**

2ND FEBRUARY 2017

**The Commissioner
Bruhat Bengaluru Mahanagara Palike
Bengaluru**

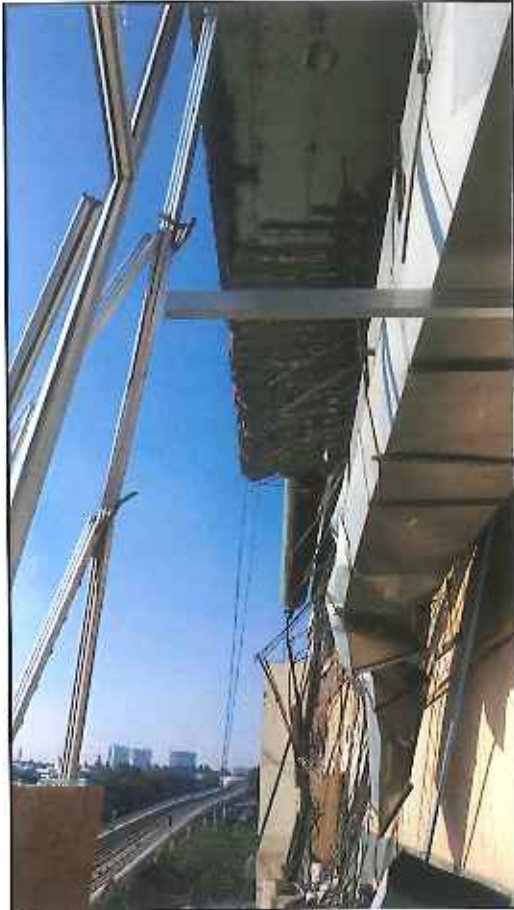
Ph. 06

**View of collapsed portion
from third floor**

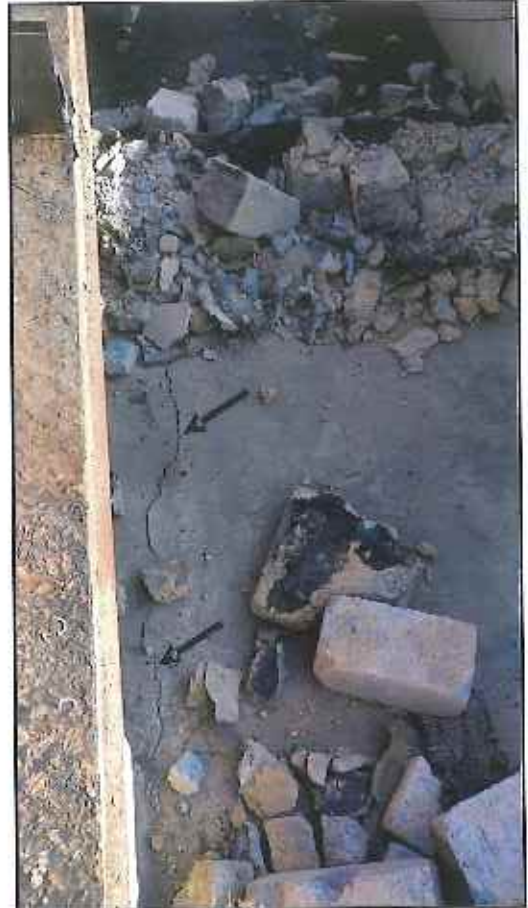
Ph. 07

**Crack in the cantilever
(Cantilever portion of roof slab
near collapsed region)**

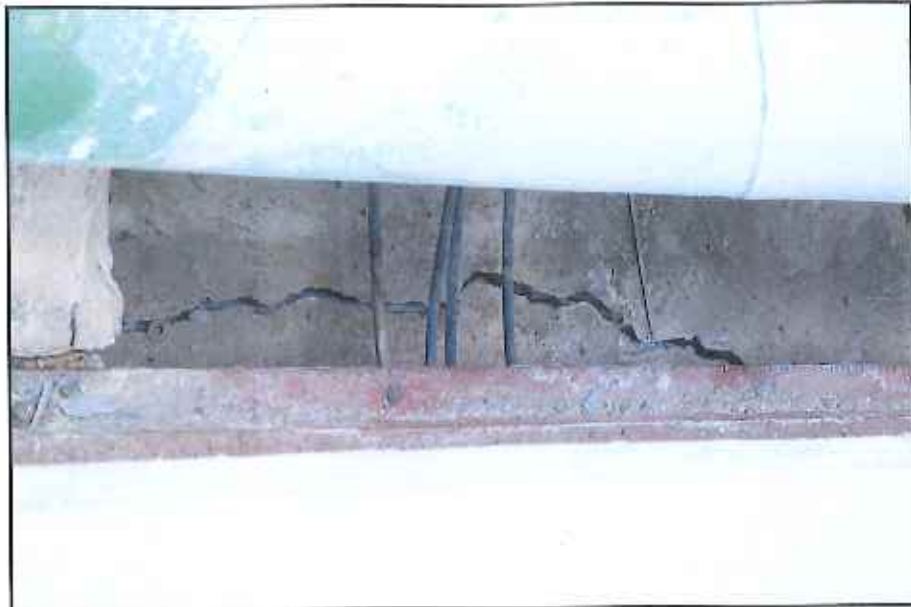
Ph. 08

**Crack in the cantilever
(Cantilever portion of roof slab near collapsed region)**

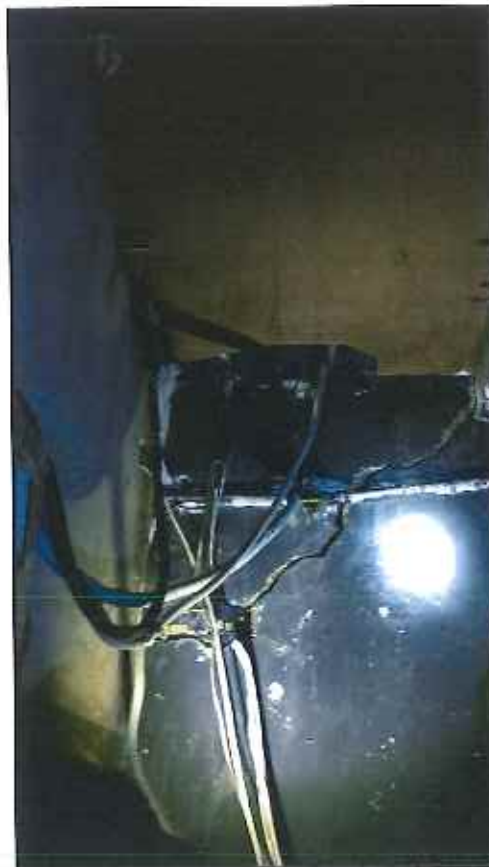
Ph. 09

7. The wall crack in the scary room region is mainly due to deflection of cantilever slab resulting from the loading of 5m height wall at the periphery.
8. The distress observed in the existing cantilever portion of roof slab near the collapsed region is mainly due to the combined effects of collapse of the adjacent slab and structural inadequacy of the cantilever section in carrying the existing loading. This portion of the slab is structurally unsafe.

Crack in peripheral wall of scary room

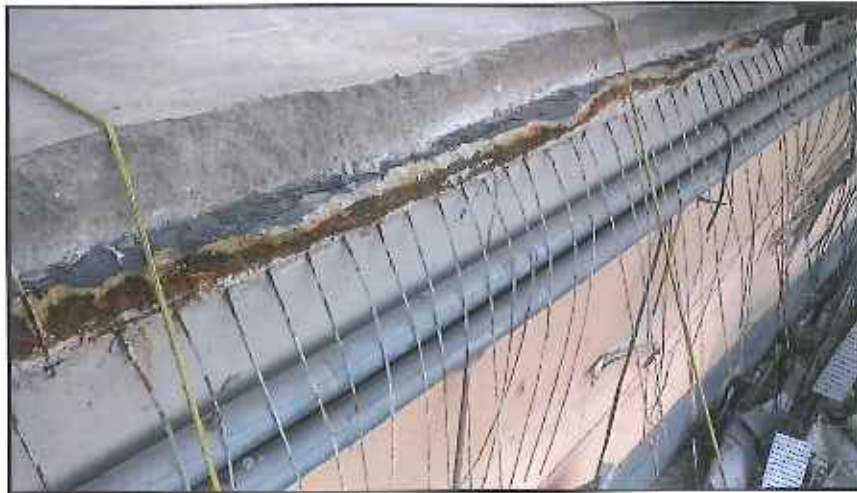
Ph. 12

9. The fractured surface indicated brownish stain in the upper portion of RCC slab. The reinforcement at the bottom was found to be hanging down. In order to see the top reinforcement, the fractured surface was gently chipped to expose the top bars. The top bars were snapped at the fractured surface. They were found to be positioned at about 100mm (Mid depth) from top of the RCC slab.

4. The calculations imply that the cantilever slab must have undergone excessive deflection and cracking before failure. The bituminous water proofing layer above the slab also, must have cracked. It is likely that the stagnated leakage water from the chiller had seeped into the crack, carrying the brown stain from the waterproofing layer. This could be the reason for occurrence of brown stain on the top portion of the fractured surface at failure location.

**Fractured cantilever slab surface with brown stains
(Typical views)**

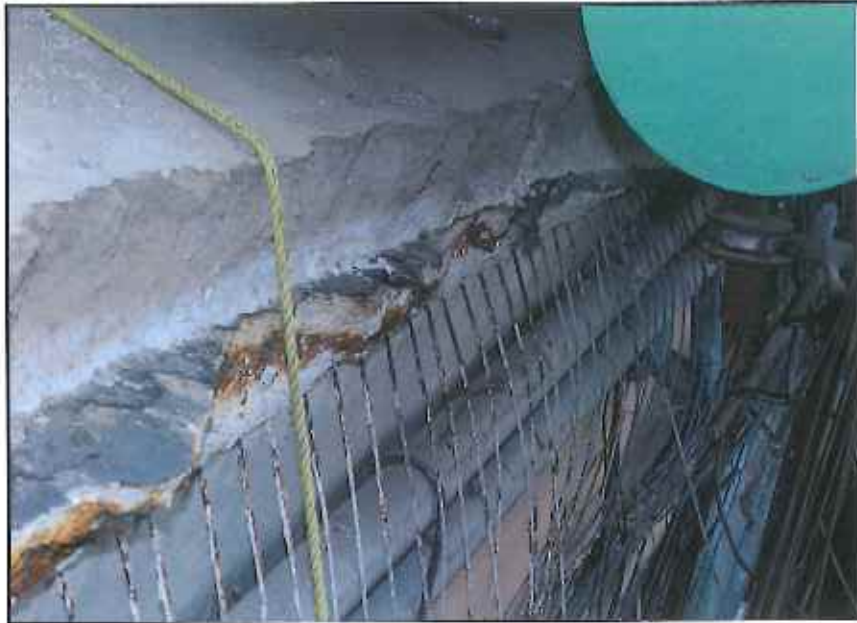
Ph. 14

10. The left over bars in the fractured region and the snapped bars indicate that the bars are corroded exhibiting brown patches and formation of scales.

6. The corrosion of bars in the collapsed region show that the cracks in the slab might have allowed the ingress of water and air into the rc section triggering corrosion.

Corroded bottom reinforcement at the fractured surface

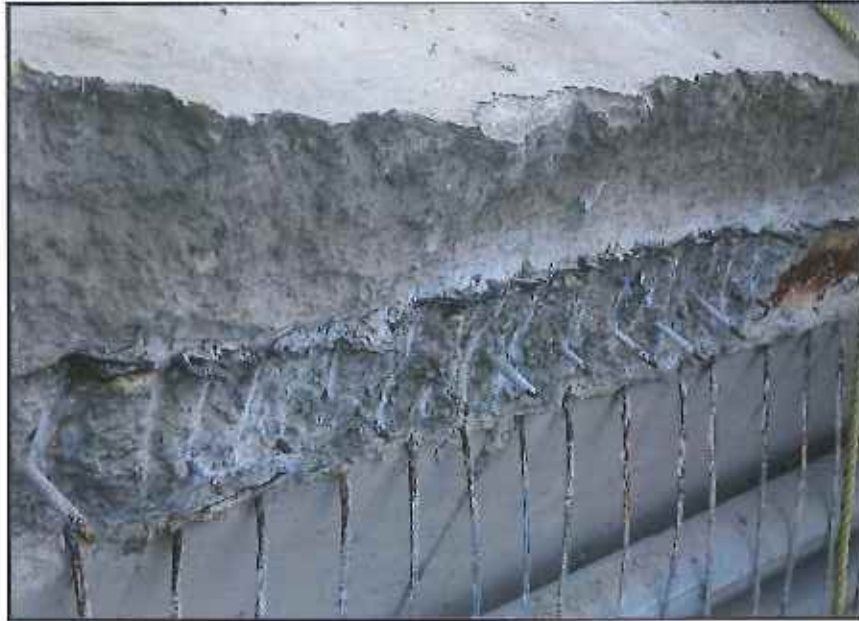
Ph. 16

**Exposed top bars of collapsed cantilever roof slab
(Typical views)**

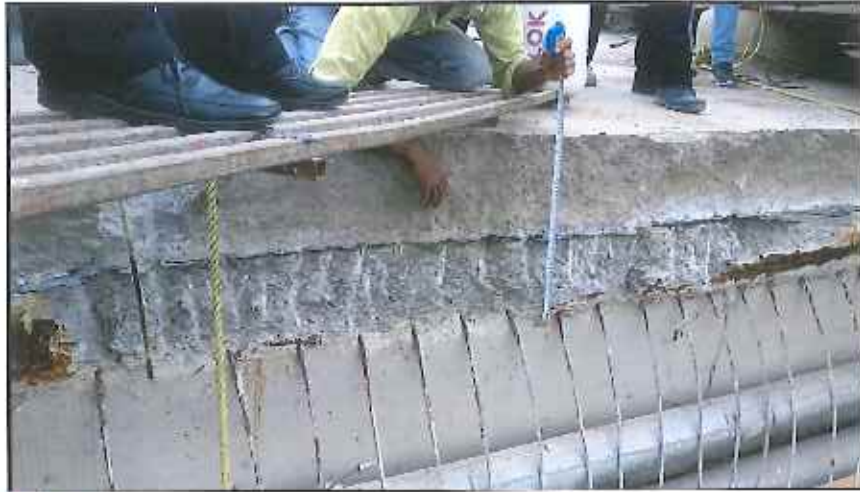
Ph. 20

8. The fractured section of the cantilevered roof slab shows the top layer of membrane waterproofing followed by screed concrete layer. A bituminous water proof layer was seen between the screed and RCC slab. The thickness of RCC slab was measured as 200mm and the thickness of screed concrete was measured as 250-275mm.

Section at fractured slab with measurement

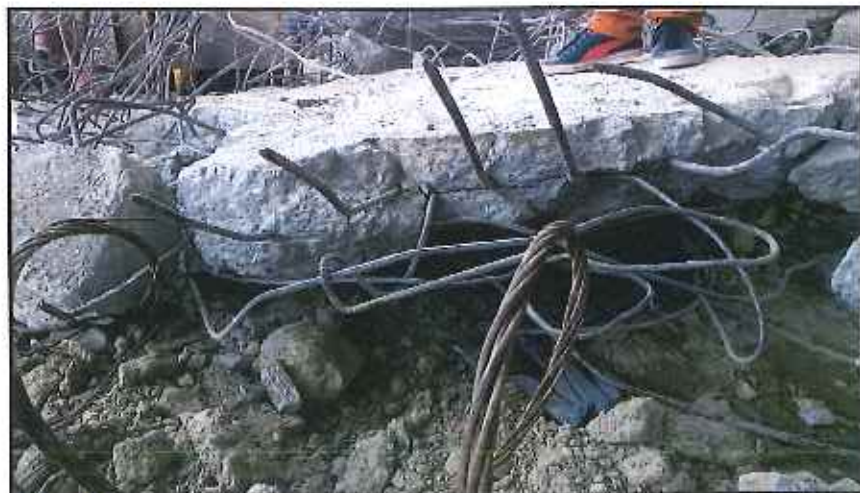
Ph. 21

2. The failure of cantilever portion of roof slab is essentially due to the structural inadequacy of the section as provided at site. The disposition of top bars to the middle of the section, reduced in – situ concrete strength and increased superimposed load due to undue thickness of screed has made the cantilever section unsafe.

View of debris of roof slab showing disposition of top bars

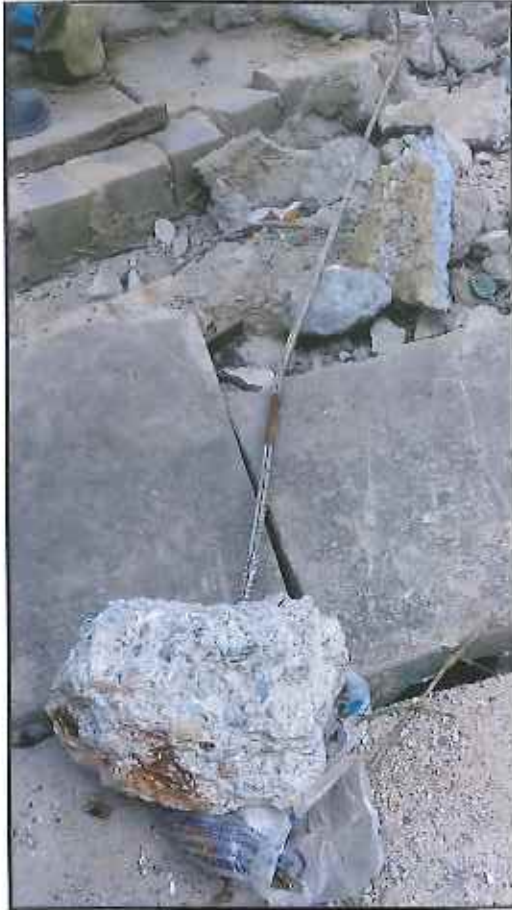
Ph. 22

**Snapped top bar of cantilever
from debris**

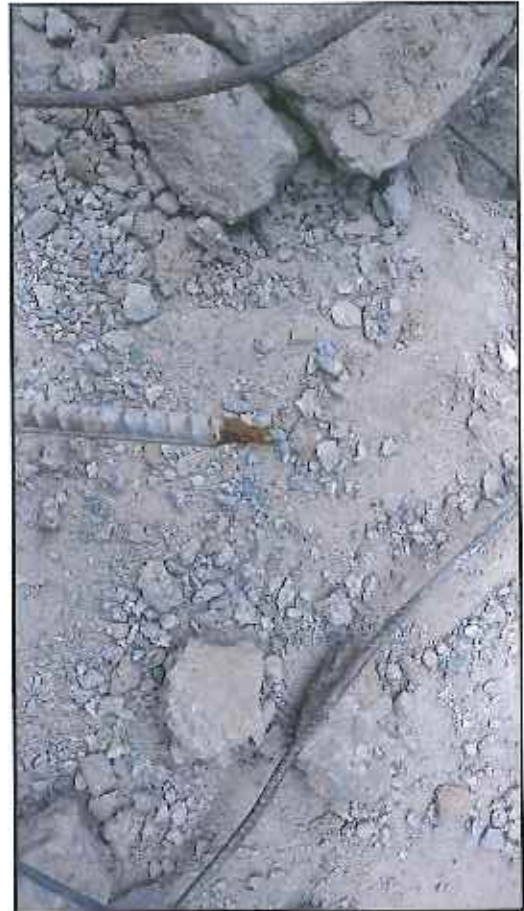
Ph. 23

**Corroded snapped top rebar
of cantilever**

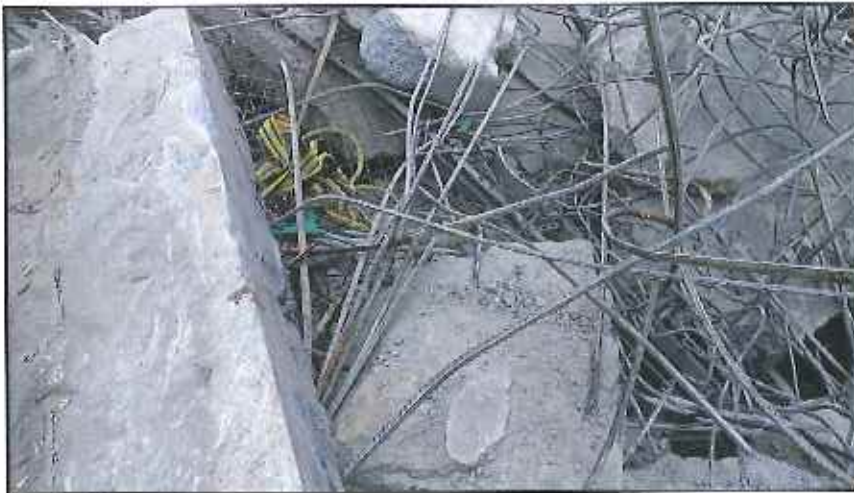
Ph. 24

5. The failure of cantilever slab in the third floor slab is mainly due to the impact of the falling debris from roof. Further, the cantilever section in third floor also has reduced structural capacity due to disposition of top reinforcement towards the middle of the section, as observed at site.

**Corroded bars seen
in debris**

**Disposition of bars in
fractured surface of
cantilever slab of
third floor
(top bars in mid region)**

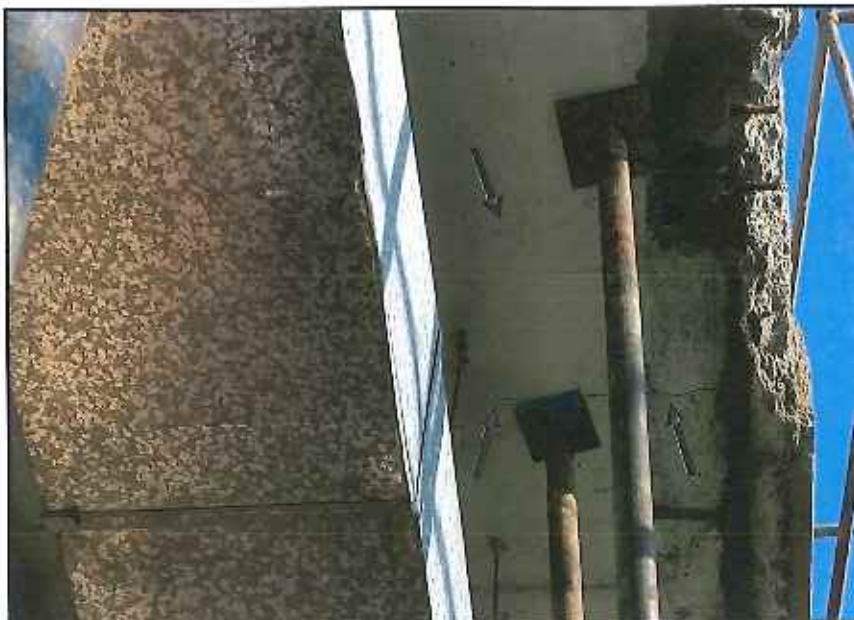
Ph. 26

**Cracks in cantilever
portion of roof slab**

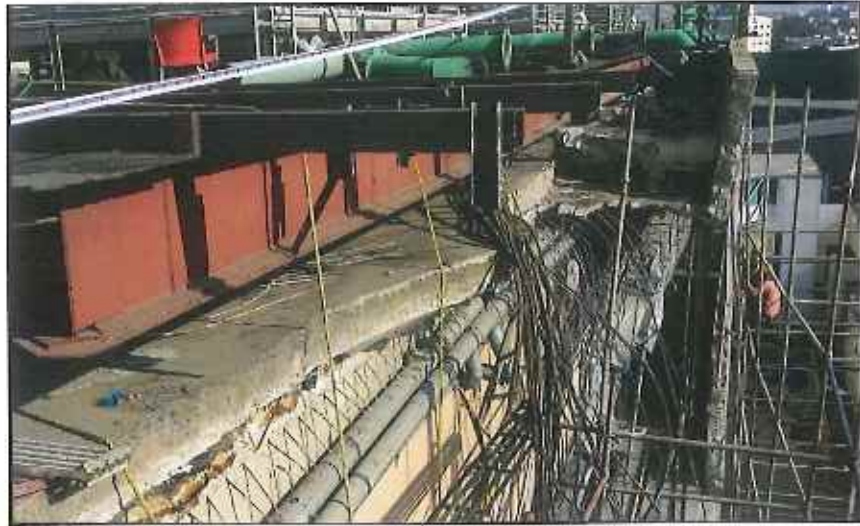
Ph. 27

View of deflected cantilever slab beyond the collapsed slab

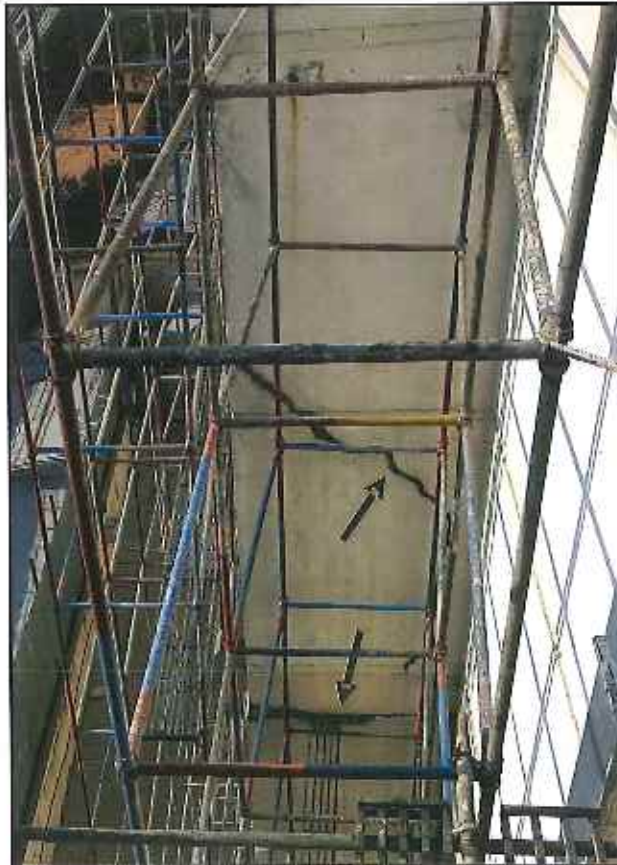
Ph. 28

Patched up cracks in the wall of scary room

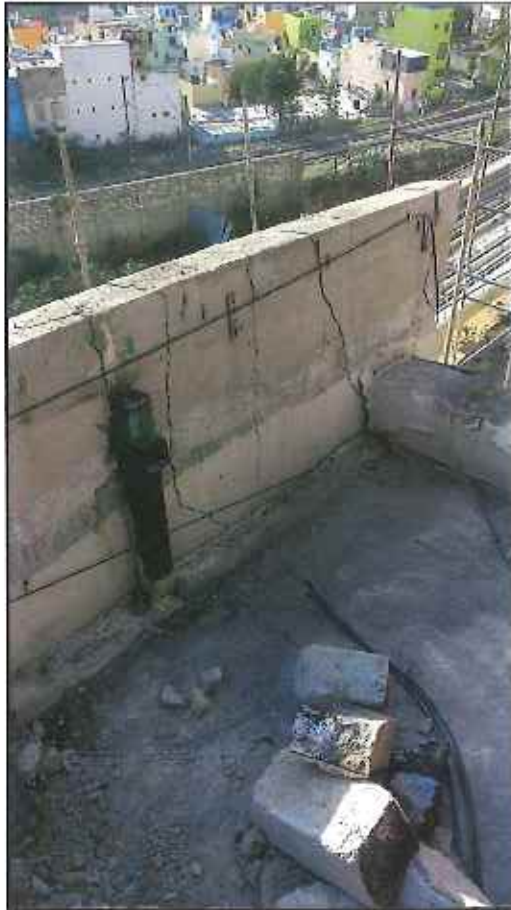
Ph. 29

Cracks in RCC parapet wall

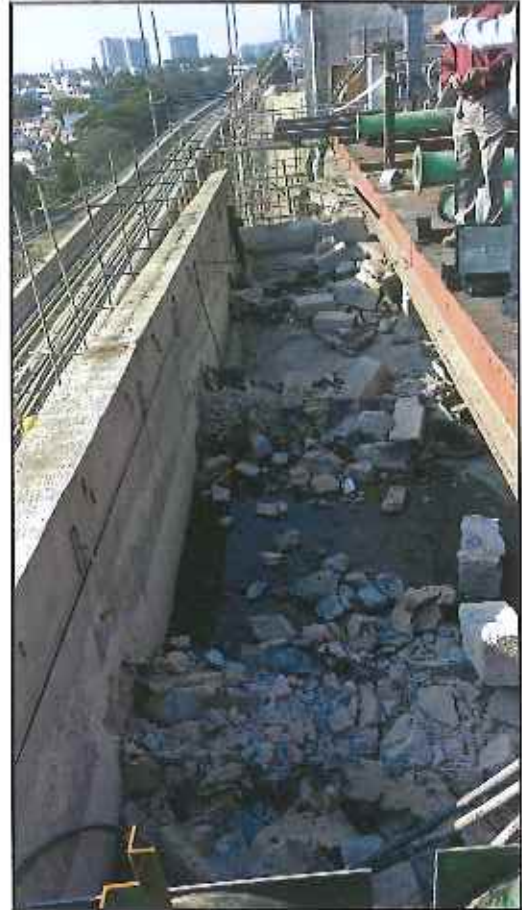
Ph. 30

**View of debris
(partly cleared)**

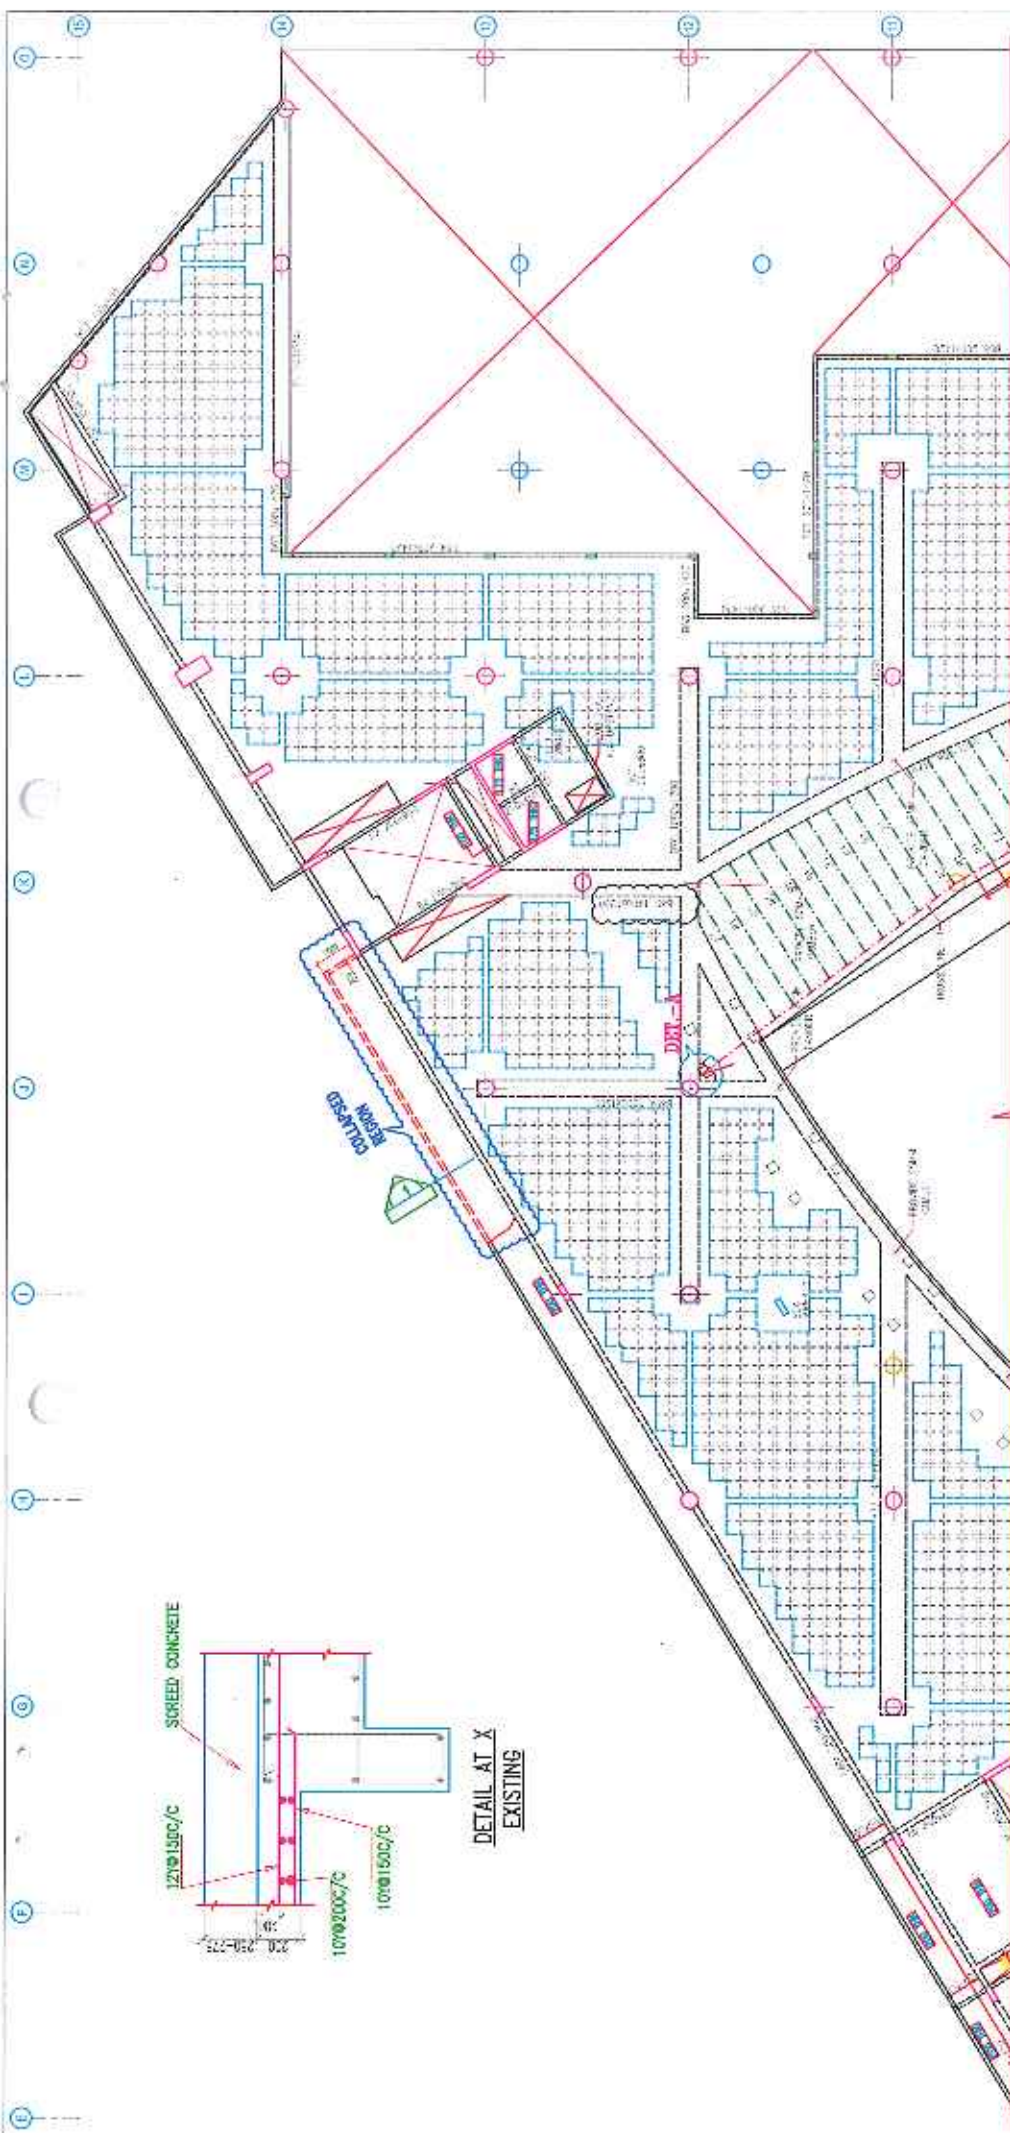
DETAIL AT X
EXISTING

Moment of resistance of the section as exist at site = 19.9kN-m which is less than the Actual moment.

From the above, it is clear that the existing section is not capable of withstanding its own self weight along with the screed and parapet wall (without considering any live load on the roof)
