Report of the Comptroller and Auditor General of India

Performance audit on Conservation and Ecological restoration of Lakes under the jurisdiction of Lake Development Authority and Urban Local Bodies

Government of Karnataka Report No.1 of the year 2015

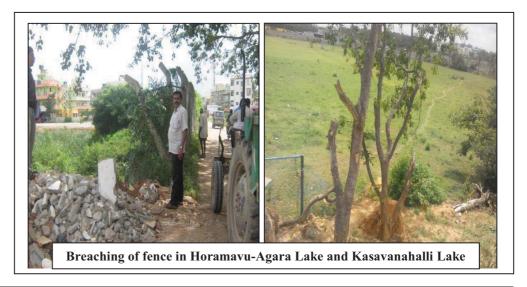
- There were cases of damage caused to fencing around lakes as can be seen from the photographs given below. BBMP had not engaged watch and ward staff in all the restored lakes. BBMP replied (February 2015) that miscreants were entering the lake area and stealing the fence materials. This indicated that there were inadequate security measures for protecting the assets related to the lakes.

The State Government (UDD) admitted (March 2015) that some miscreants in order to dump debris had damaged fencing for easy access and this would be rectified. The reply is not acceptable, as the primary duty of implementing agencies was to safeguard the lake area by deploying sufficient security soon after the lake was taken over.

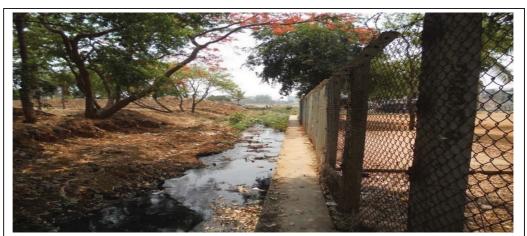
Photograph below taken during JPV also illustrates the level of pollution in a test-checked lake.

Dasarahalli Lake main drain (inlet 1 of the lake) receives all the effluents from Peenya Industrial area as evident from the thick viscous black water flowing in the drain

Recommendation 9: BWSSB should, in coordination with implementing agencies/custodians of the lake, construct STPs and use them optimally to ensure that untreated sewage is not let into the lakes.

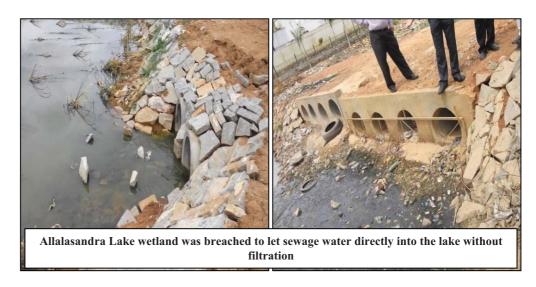
The constructed wetlands were also felt to be insufficient to absorb the pollutants due to absence of aquatic weeds. Due to lack of multilayered slope design in wetland construction, the backlash of sewage to the drain was entering the settlements near the foreshore region, as observed in the case of Allalasandra Lake.

The State Government (UDD) accepted (March 2015) the observation and stated that action would be taken to rectify the breached bunds as well as inlet levels would be ensured in the lakes.

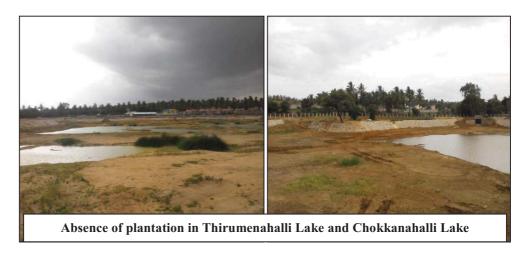
In two test-checked lakes, Chokkanahalli and Thirumenahalli, the afforestation works were carried out during 2010-11 in the lake bed and thereafter lake rejuvenation works including desilting were done during 2013-14. Audit observed during JPV, that no plantations had survived after the rejuvenation works were carried out. The efforts towards afforestation, therefore, did not yield the intended result.

The State Government (UDD) agreed (March 2015) that the works of afforestation were carried out while fencing works were in progress. This was necessary to bring the evicted area of encroachment under plantation. The reply is not acceptable as these plantation works were destroyed due to desilting and formation of elevated ring bunds in the lake. This resulted in the expenditure incurred on these afforestation works as wasteful.

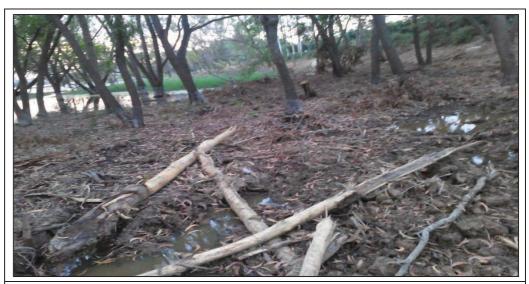
Conversely, during JPV of Kaigondanahalli Lake, Audit observed that trees had been cut indiscriminately to pave way for laying sewage diversion pipe line.

Cutting of trees in Kaigondanahalli Lake
