CENTRAL POLLUTION CONTROL BOARD

INSPECTION REPORT OF VARTHUR LAKE, BENGALURU

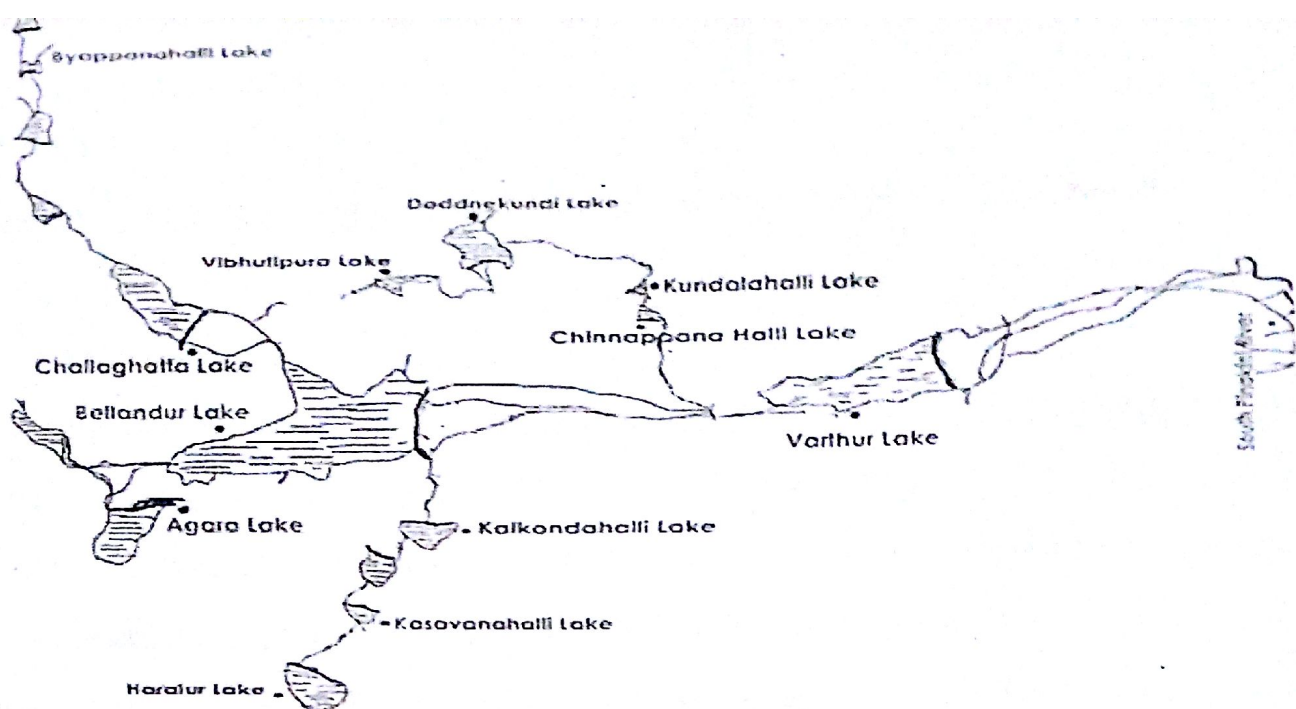
Figure 2: Interconnection of Lakes showing the linkage of Varthur with other lakes

- i. **Accumulation of foam and odour nuisance due to discharge of untreated sewage**
 - The domestic sewage generated in Koramangala-Challaghatta valley of Bengaluru South district is around 600 MLD while the total capacity of the wastewater treatment plants is approximately 300 MLD. Only 50% of the wastewater generated in the catchment is currently being treated and the remaining untreated sewage is discharged into various lakes. Varthur Lake is part of interconnected system of tanks and canals that receive virtually all the surface runoff, wastewater, and sewage from this catchment area as shown in the figure 2.

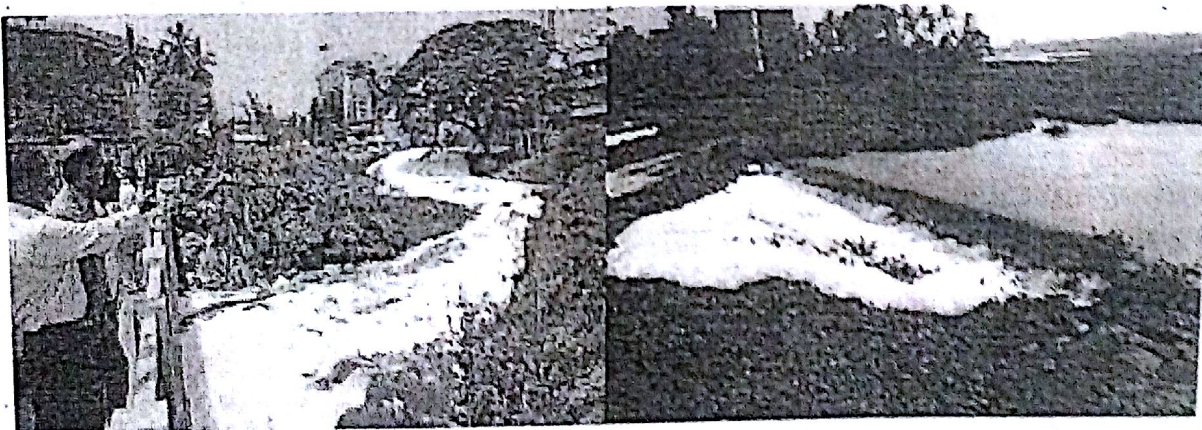
Photo: Foaming in Varthur lake

- The lake was found completely filled & eutrophied and water is in anoxic-anaerobic condition.
- There was heavy rainfall in Bengaluru during April, 2015 (around 80mm). Since, most of the storm water drains/ Rajakaluves are being encroached, the surface runoff is reaching into the lakes from catchment area. The lake is observed to be completely filled and overflowing. The outfall of Varthur weir is very rocky & sloppy and the effluents containing high surfactants, sodium and potassium hydroxides flowing over it leads to foam formation due to rigorous agitation.

- The state Government shall directed
 - To restore Varthur Lake by adopting in situ measures such as de-silting, de-weeding, bioremediation, aeration, bio-manipulation, nutrient reduction, withdrawal of anoxic hypolimnion, constructed wetland approach or any other successfully tested eco-technologies etc. depending upon the site conditions.

- To earmark the boundary of the lake, and establish bunds along the periphery of the lake.
 - To instruct the concerned agency to identify all sewage inlet points, divert the sewage entering varthur lake to the Koramangala-Challaghatta valley STP for treatment. The entire catchment area needs to be connected with proper sewerage network.

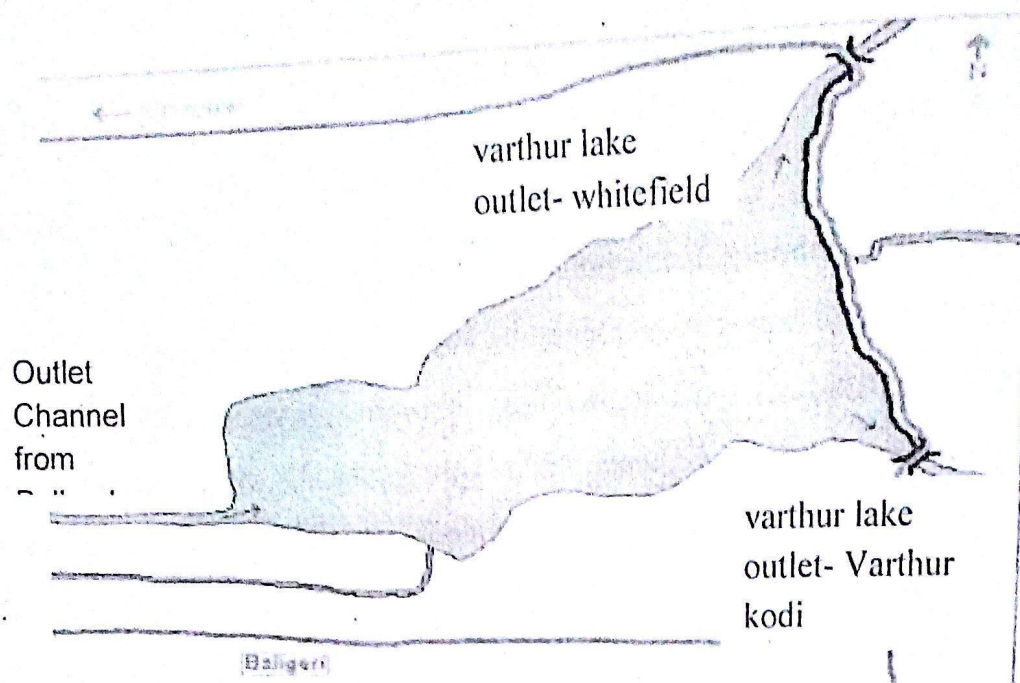
Figure 3: sampling locations

The team collected grab samples at three critical points: varthur lake outlet- whitefield, varthur lake outlet channel- varthur kodi and outlet of Bellandur lake and results are depicted in table 1 given below.

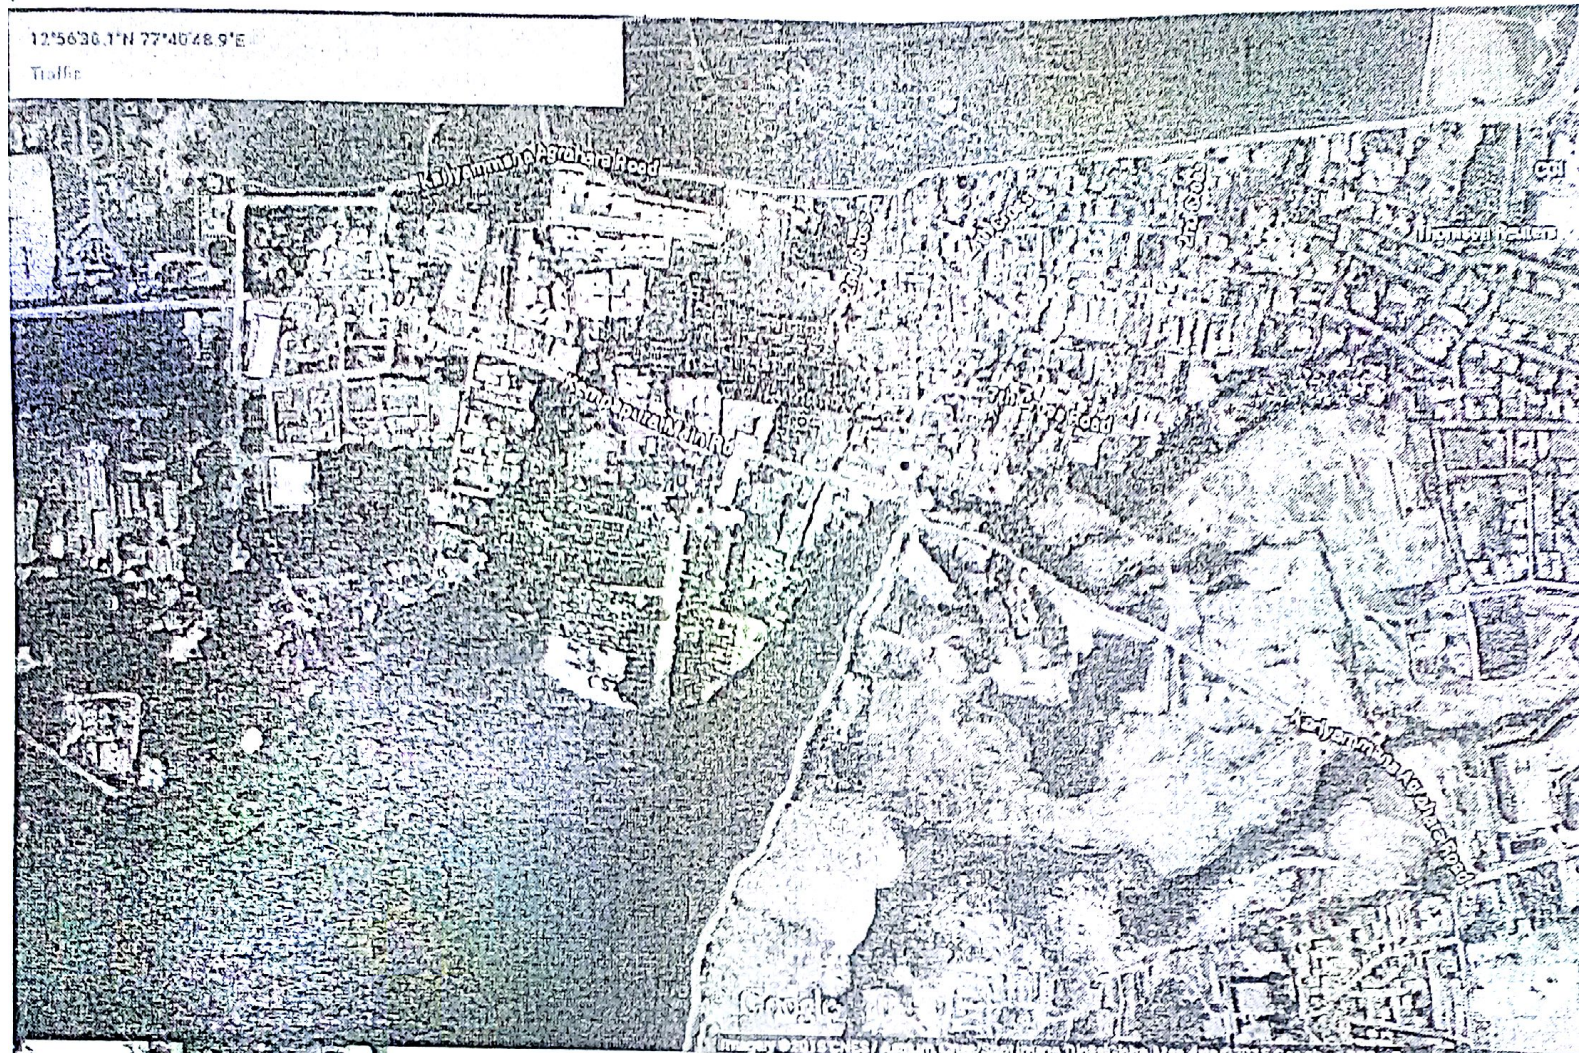
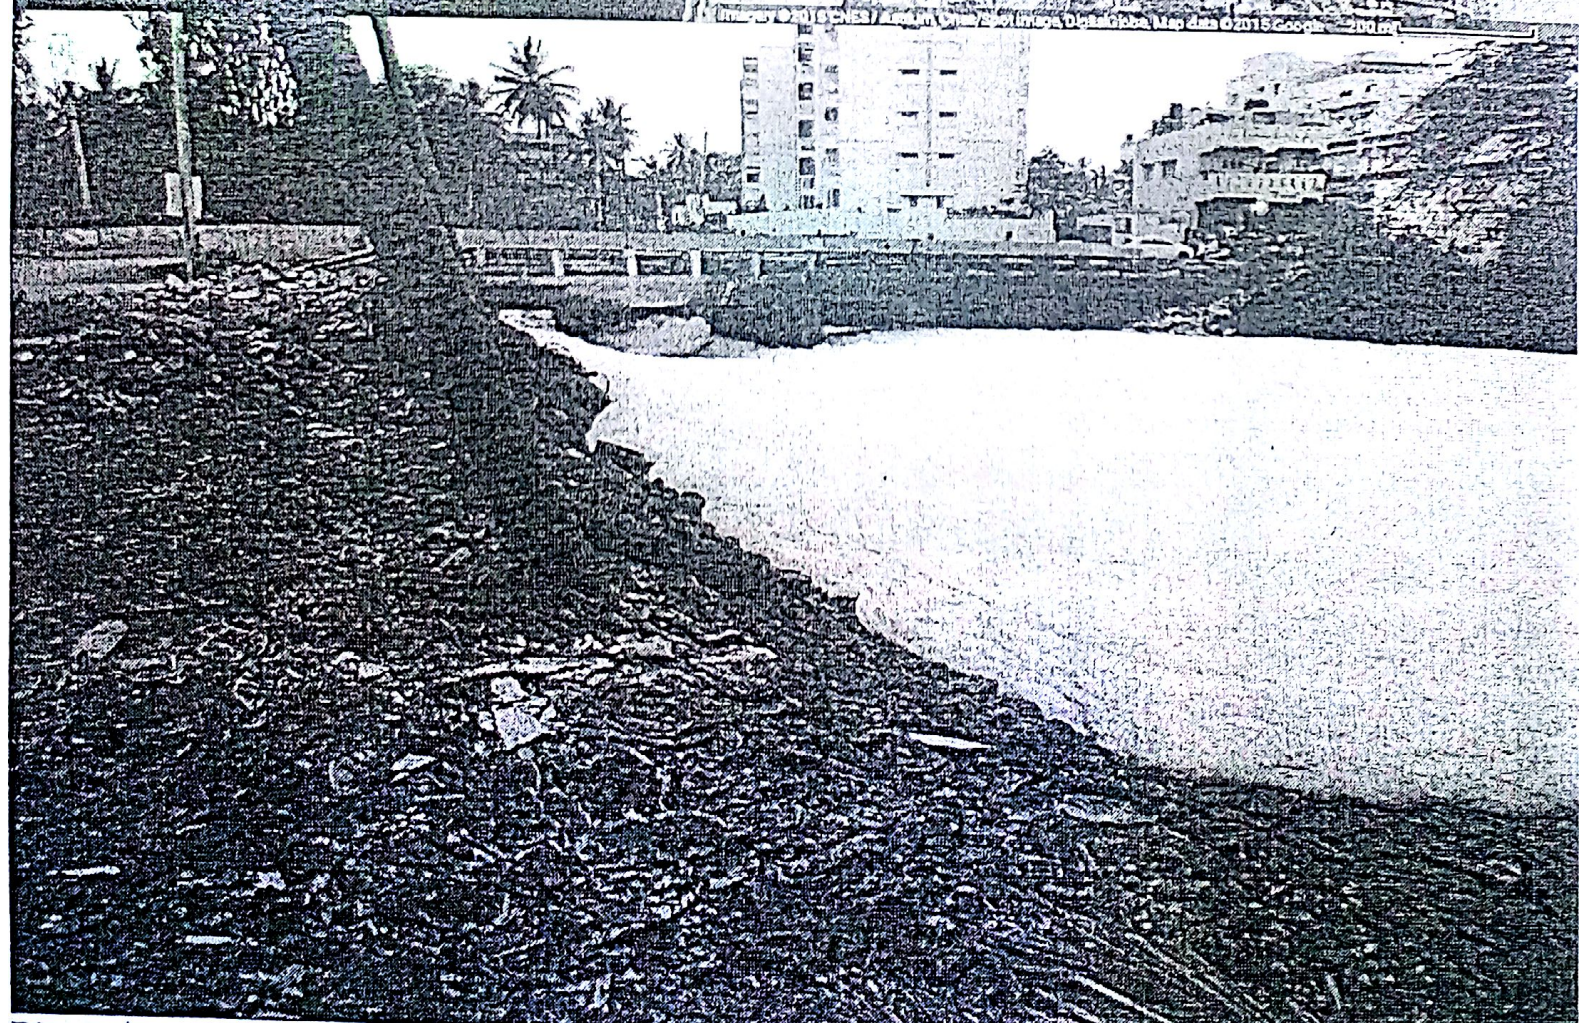
Photo 2: Sampling location: Balandur lake outlet, Yemalur (Inlet to Varthur lake) 12°56'38.1"N 77°40'48.9"E

- Dissolved oxygen decides the prevailing conditions of the water. Dissolved oxygen (DO) at inlet of Varthur lake is more compared to other two locations. This shows that water in the lake is stagnated, due to inflow of raw sewage and other effluents.

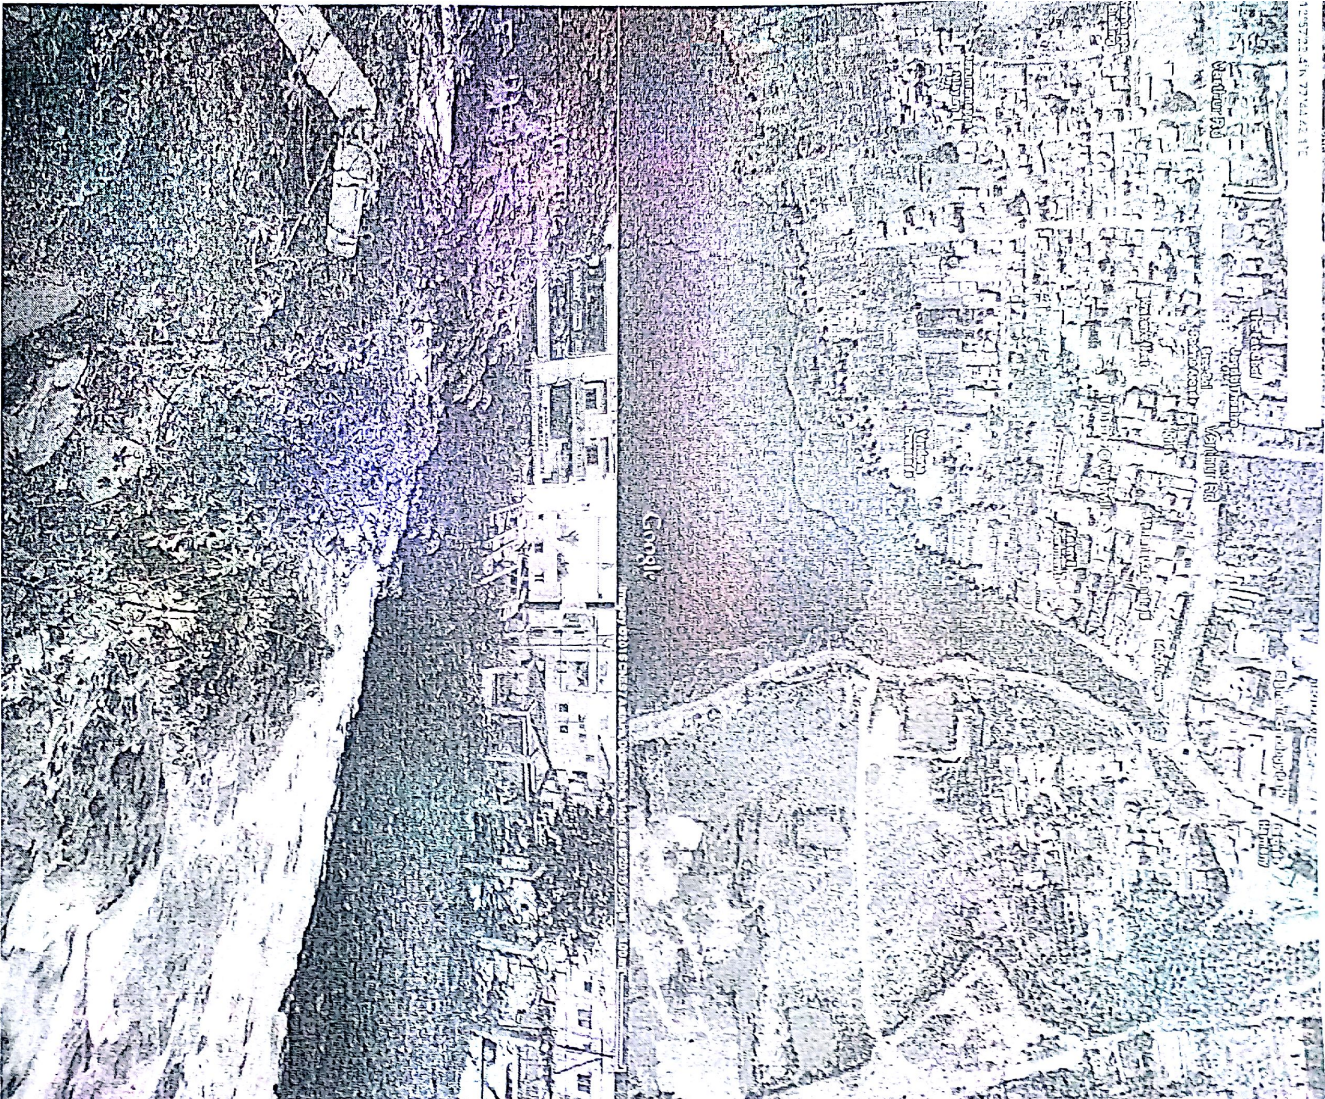
Photo 4: Sampling location: Varthur lake outlet channel, Whitefield (12°57'23.4"N 77°44'42.1"E)

- It is envisaged from the analysis results that the dissolved oxygen is varying between 0.7 to 1.61 mg/l. which clearly indicates that the lake is in hypoxic condition posing threat for the sustenance of aquatic life. Hypoxic and anoxic conditions can be correlated with a higher demand for oxygen for bacterial decomposition, which results in higher decomposition rates of organic matter, and consequently creates an anaerobic environment.
