Performance audit on Conservation and Ecological restoration of Lakes under the jurisdiction of Lake Development Authority and Urban Local Bodies

Report No.1 of the year 2015

**Government of Karnataka
Report No.1 of the year 2015**

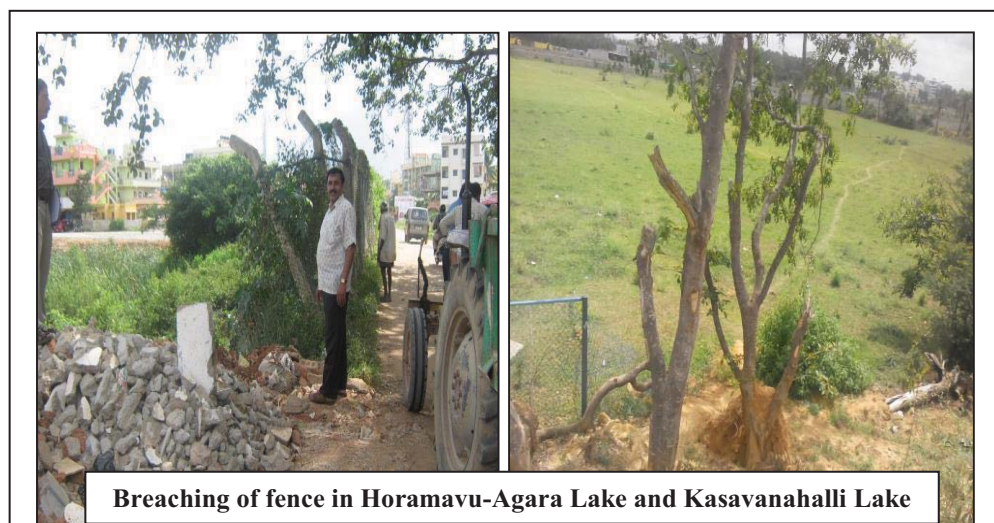
- There were cases of damage caused to fencing around lakes as can be seen from the photographs given below. BBMP had not engaged watch and ward staff in all the restored lakes. BBMP replied (February 2015) that miscreants were entering the lake area and stealing the fence materials. This indicated that there were inadequate security measures for protecting the assets related to the lakes.

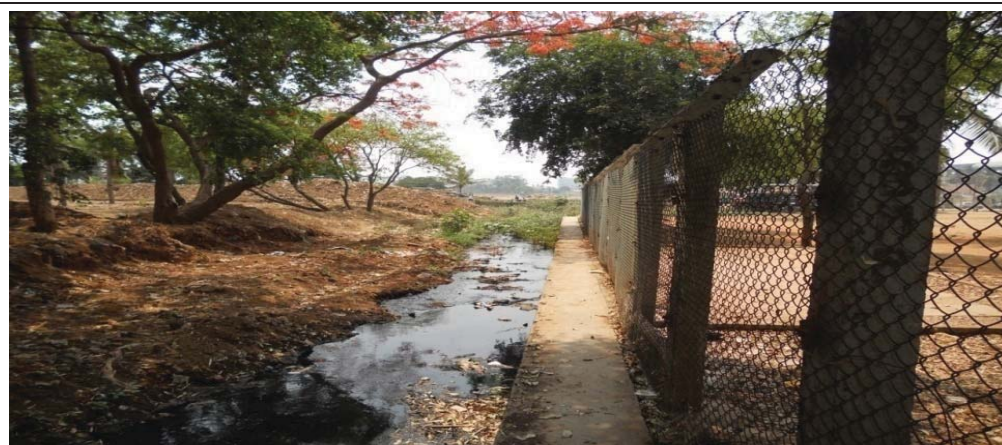
Dasarahalli Lake main drain (inlet 1 of the lake) receives all the effluents from Peenya Industrial area as evident from the thick viscous black water flowing in the drain

Recommendation 9: BWSSB should, in coordination with implementing agencies/custodians of the lake, construct STPs and use them optimally to ensure that untreated sewage is not let into the lakes.

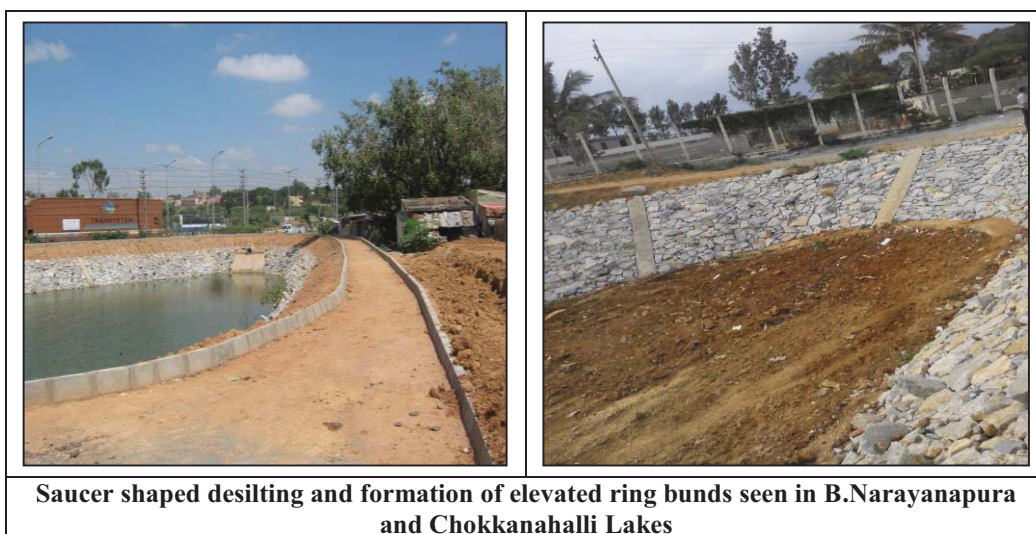
The BDA stated (January 2015) that the deepening of the lake bed was carried out to bring saucer shape to the lake bed. The reply is not acceptable as this was contrary to the expert guidance given (July 2008) by the PCCF. The State Government (UDD) admitted (March 2015) that there was excessive desilting due to accumulation of debris and other wastes in the lakes which was due to delay in the process of preparation of DPRs and execution of the work. Also, slushy soil cannot be used for formation of embankment. The reply is not acceptable as accumulation of debris and other wastes should be avoided once the lake has been handed over to the implementing agencies. For categorising the soil as 'slushy soil', there should be proper soil test reports which were not there. Also, bills showed that that even dry soil was transported out of the lake area. As such, the issue calls for investigation and fixing of responsibility for doing excess excavation as compared with DPRs.

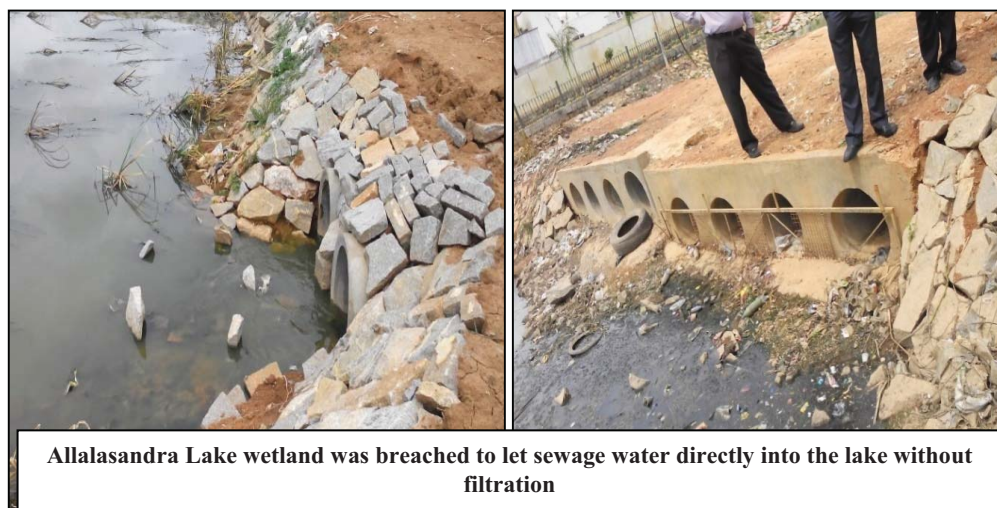
The constructed wetlands were also felt to be insufficient to absorb the pollutants due to absence of aquatic weeds. Due to lack of multilayered slope design in wetland construction, the backlash of sewage to the drain was entering the settlements near the foreshore region, as observed in the case of Allalasandra Lake.

The State Government (UDD) accepted (March 2015) the observation and stated that action would be taken to rectify the breached bunds as well as inlet levels would be ensured in the lakes.

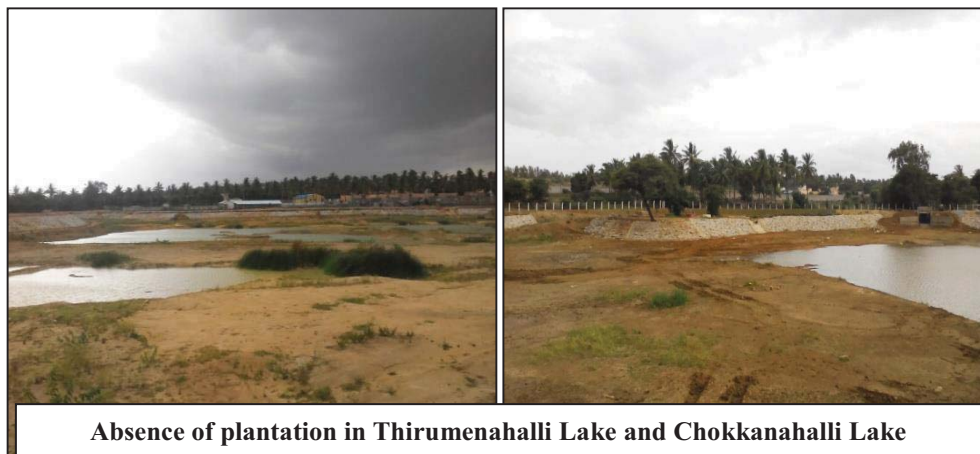
- In two test-checked lakes, Chokkanahalli and Thirumenahalli, the afforestation works were carried out during 2010-11 in the lake bed and thereafter lake rejuvenation works including desilting were done during 2013-14. Audit observed during JPV, that no plantations had survived after the rejuvenation works were carried out. The efforts towards afforestation, therefore, did not yield the intended result.

The State Government (UDD) agreed (March 2015) that the works of afforestation were carried out while fencing works were in progress. This was necessary to bring the evicted area of encroachment under plantation. The reply is not acceptable as these plantation works were destroyed due to desilting and formation of elevated ring bunds in the lake. This resulted in the expenditure incurred on these afforestation works as wasteful.

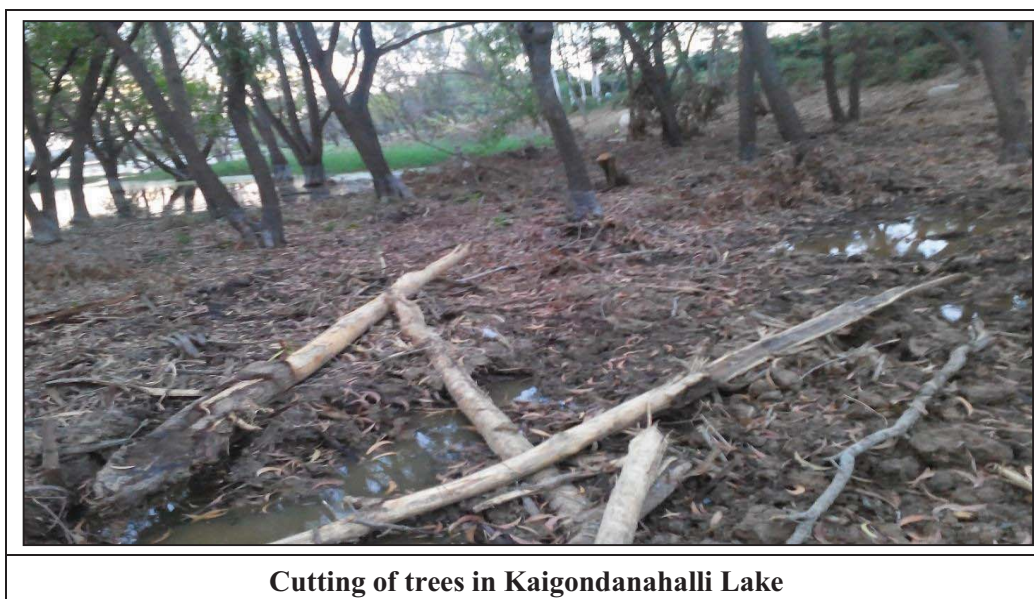
Conversely, during JPV of Kaigondanahalli Lake, Audit observed that trees had been cut indiscriminately to pave way for laying sewage diversion pipe line.

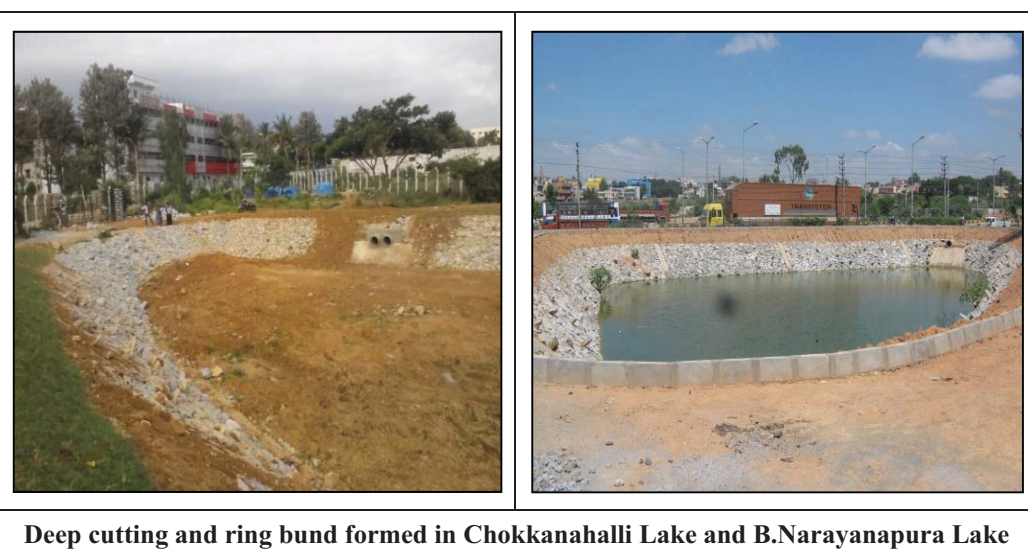
Photographs of such embankment works at Chokkanahalli Lake and B.Narayanapura Lake are given below:

The State Government (UDD) replied (March 2015) that due to urbanisation, vast area was not available for maintaining the foreshore area. The reply is not acceptable as the available foreshore area has been destroyed to create elevated ring bund contrary to the directions issued and could therefore not support the flora and fauna and aquatic life.

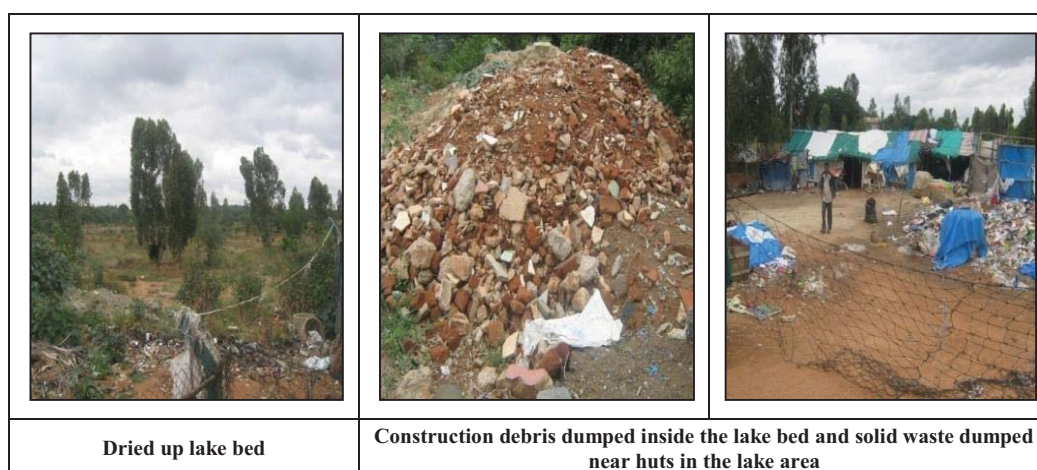
- ❖ The village map and other records revealed that the adjoining Survey.No.63 of Mullur village which was part of the lake is now shown as private land in the latest certified revenue survey map (2010).
- ❖ BBMP had planted trees in the lake bed area and no restoration works were taken up either by BBMP or BDA to revive the lake as a fresh water body.
- ❖ There were no inlets to the lake and thus, the entire lake bed had dried up.
- ❖ Lake was polluted with solid waste and construction debris and the pollution level was also not being monitored by any of the agencies.

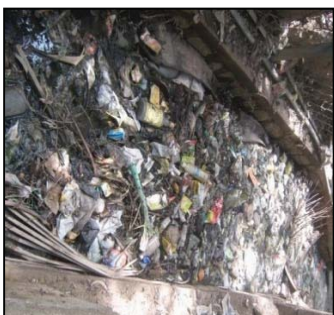
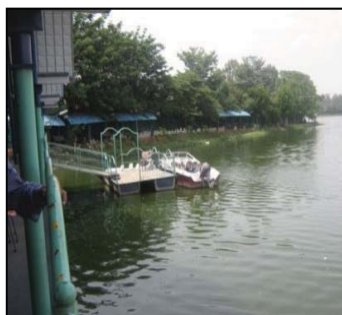
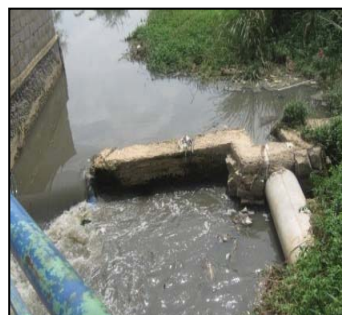
- ❖ A walkway bridge (near Tambuchettypalya Road) was seen damaged, posing danger to the lake users. The LDA replied (April 2015) that walkway bridge had been repaired.

Lake area with solid waste	Motor boats in lake area	Inlet from STP side bringing polluted water

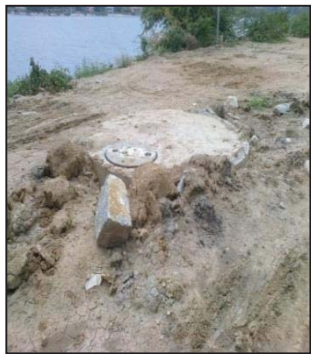
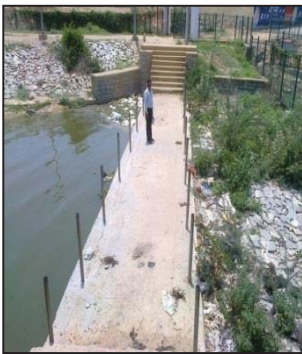
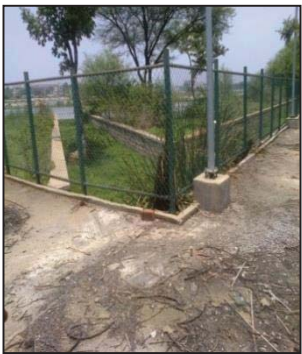
- ❖ Restoration works carried out without removal of encroachments.
- ❖ BDA had formed a residential layout in the lake area. It also irregularly diverted 11 acres of lake for formation of park as part of rejuvenation works in violation of rules.
- ❖ Fencing was breached and left open in many stretches to provide access roads to the nearby residential areas.
- ❖ The level of pollution was not assessed by any agency. BWSSB laid UGD network very close to the water spread area with the approval of LDA and BDA.
- ❖ The treated water flowing from Jakkur Lake was not entering the lake as the inlet was connected to sewage diversion channel and wetland remained dry.

BWSSB trunk sewer chamber close to the water spread area	Lowered waste weir without flow	Constructed wetland without any water

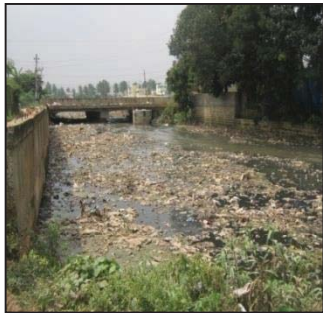
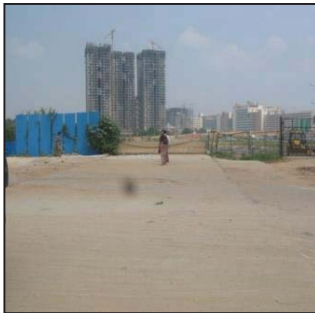
- ❖ The lessee had provided restaurants, party halls, amusement and water theme parks, motor boats *etc.*, thereby polluting the lake area. Due to sewage ingression, the entire wetland region was covered with water hyacinth and floating debris. The level of pollution was not assessed by any agencies. LDA replied (April 2015) that action would be taken to improve the ecological health of the lake.

Sewage with floating debris from SWD entering the lake	Formation of Special Economic Zone in the Buffer zone	Wetland fully covered with water hyacinth and weeds

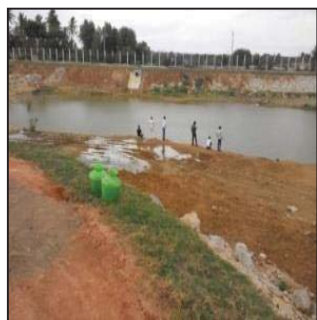
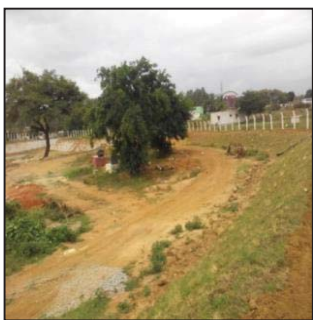
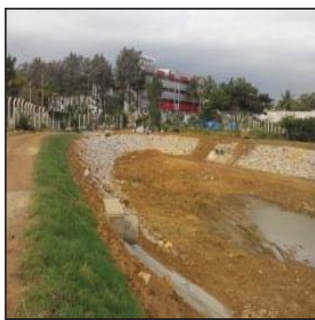
- ❖ The *atchcut* area across the main bund had been demarcated for residential site formation.
- ❖ The lake bund was used as a road to provide connectivity to the nearby areas.
- ❖ During JPV, a graveyard was noticed inside the lake area. Local people were fishing in the lake.
- ❖ The constructed inlet was defective as the opening of inlet was below the existing waste weir. The inlet provided with silt trap, screen barrier *etc.*, was clogged and the excess water was not flowing into the lake.
- ❖ The pollution level was not being monitored by any of the agencies.

Fishing in the lake	Graveyard inside the lake	Inlets opening to the lake below the level of waste weir

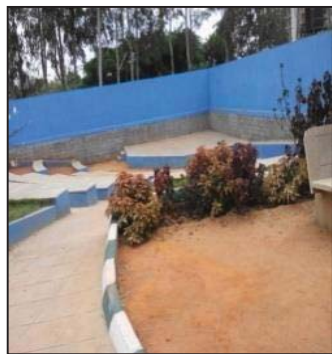
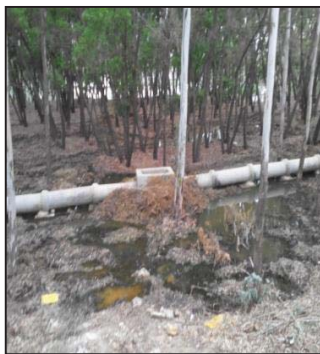
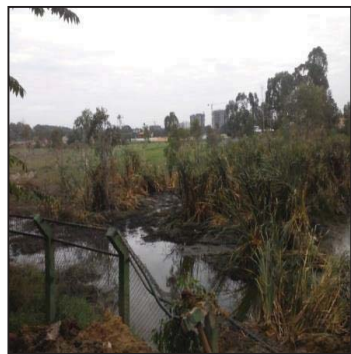
- ❖ The Sarjapura main road is passing through the lake bund, thereby reducing the lake area.
- ❖ Natural flow of rain water/storm water had been restricted to flow through pipeline due to the formation of ring bund.
- ❖ Sewage diversion line was laid inside the water spread area by cutting trees.
- ❖ The foreshore area on the southern part of the lake was being developed into residential complex, breaching the buffer zone.
- ❖ An open amphitheatre was constructed in the lake bed, reducing the lake area.
- ❖ KSPCB (November 2013) classified the quality of water of lake as “E” category, which was below the prescribed standard “B” for outdoor bathing in developed lakes.
- ❖ An NGO (MPSMAS) had taken up the responsibility to maintain the lake.

Amphitheatre inside the lake	Diversion pipeline laid inside lake	Loss of foreshore area due to formation of ring bund in the lake

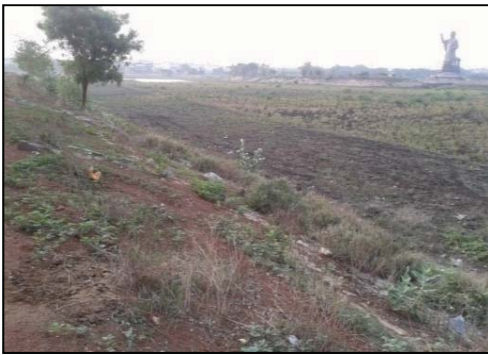
- ❖ The lake has been de-watered for restoration work and for erection of the statue of Lord Bashweshwara. The lake area where the statue was erected had dried up as indicated in the photograph below.
- ❖ The inflow of sewage from one inlet had stagnated on one side of the lake as indicated in the photograph below.
- ❖ The pollution level was not being monitored by any of the agencies.

Sewage being collected at one side	Dried up area near statue

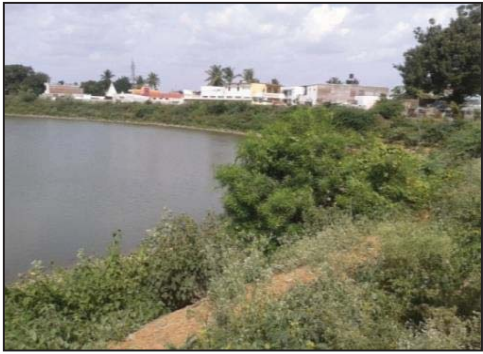
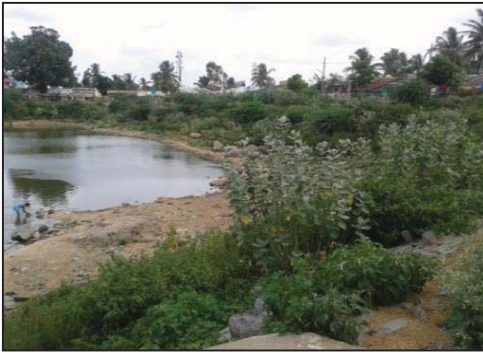
- ❖ Due to non-maintenance, the lake periphery and the bund were full of bushes/weeds as shown in the photograph below.
- ❖ Open defecation was prevalent and clothes were being washed in the lake polluting the lake. This was shown in the photograph below.
- ❖ KSPCB categorised the water quality as “D” which did not conform to the required standard of “B” class.

<p>Bushes/weeds growing in the periphery of lake</p>	<p>Washing clothes in lake area</p>
