**EXPERT COMMITTEE REPORT ON COLLAPSE OF
CANTILEVER PORTION OF COMMERCIAL BUILDING
AT SAMPIGE ROAD, MALLESWARAM,
BENGALURU**

2ND FEBRUARY 2017

**The Commissioner
Bruhat Bengaluru Mahanagara Palike
Bengaluru**

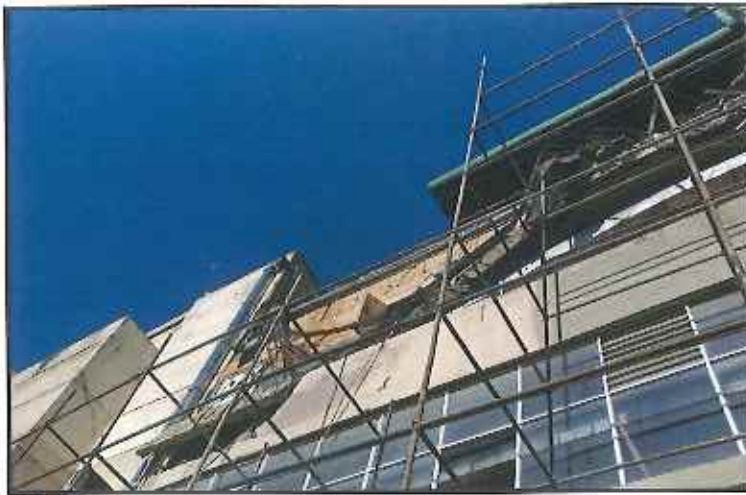
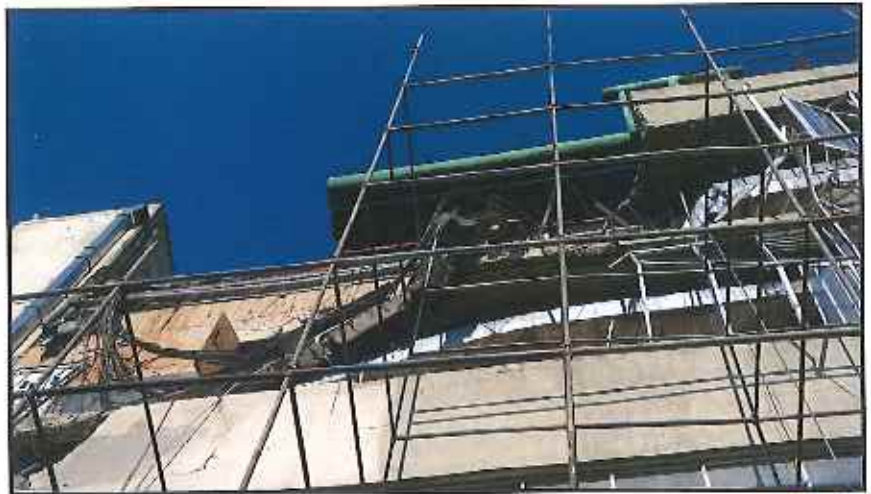
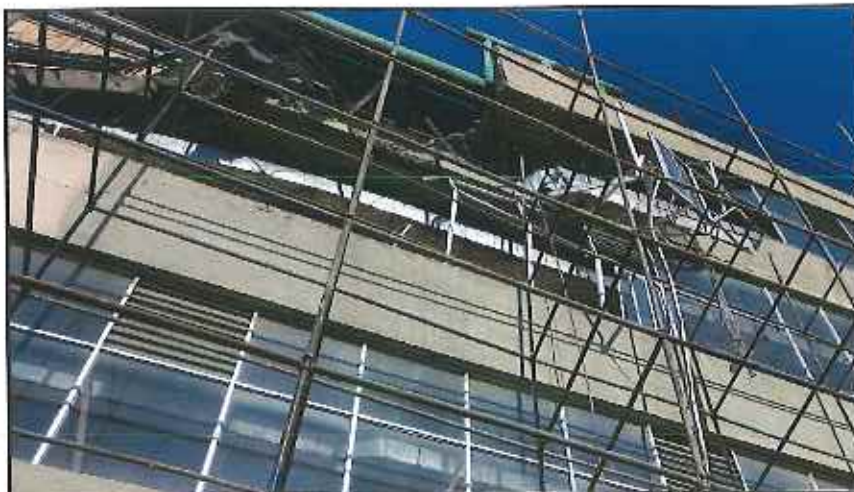
Ph. 01

**General views of the
collapsed region**

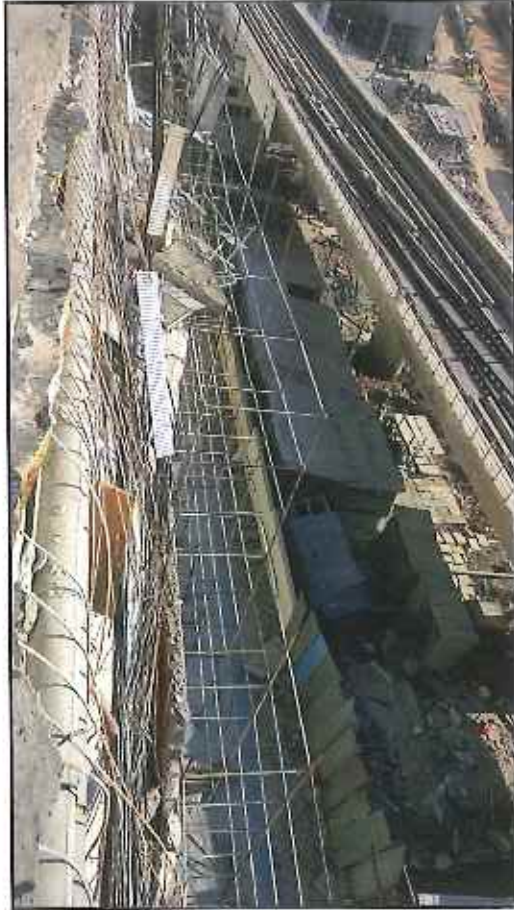
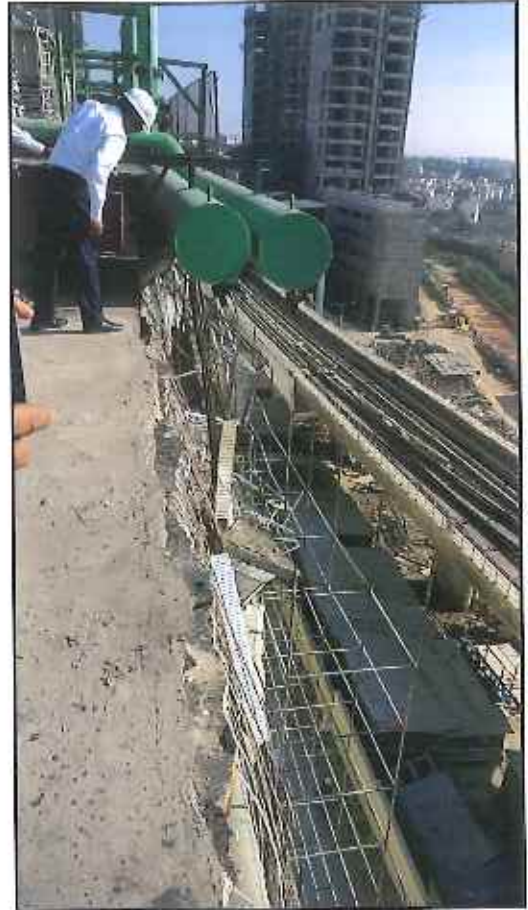
Ph. 05

Top view of collapsed cantilever roof slab

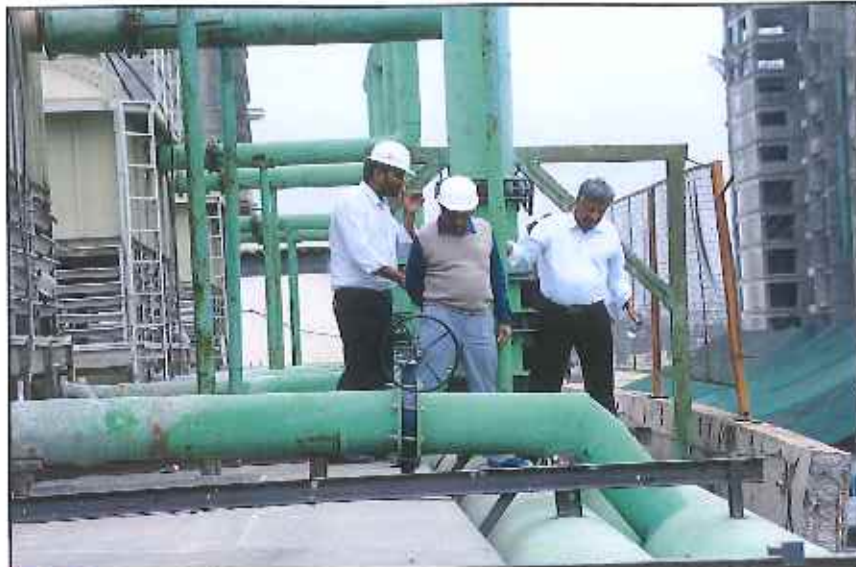
Ph. 10

Inspection of cracks

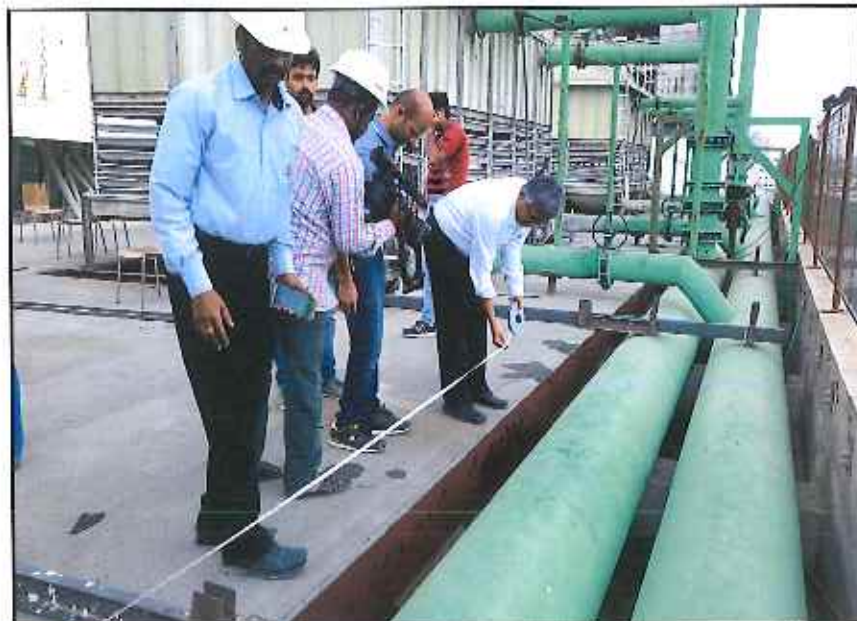
Ph. 11

Measurement of distressed portion

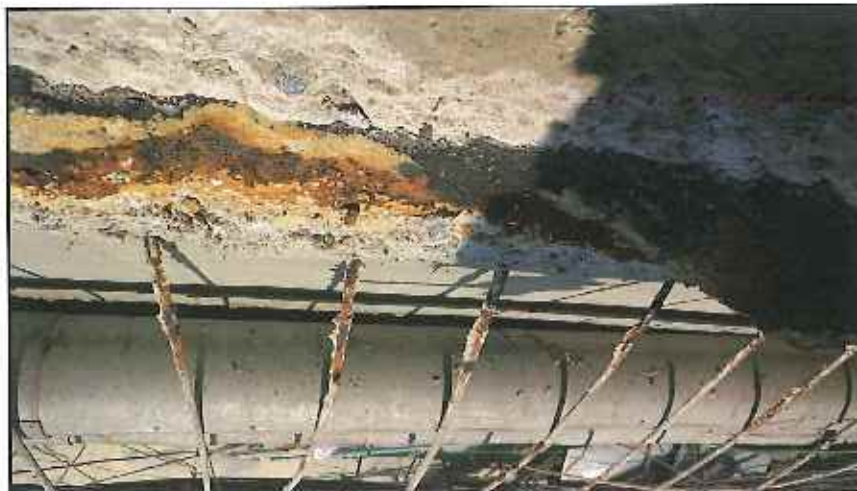
Ph. 13

**Fractured cantilever slab surface with brown stains
(Typical views)**

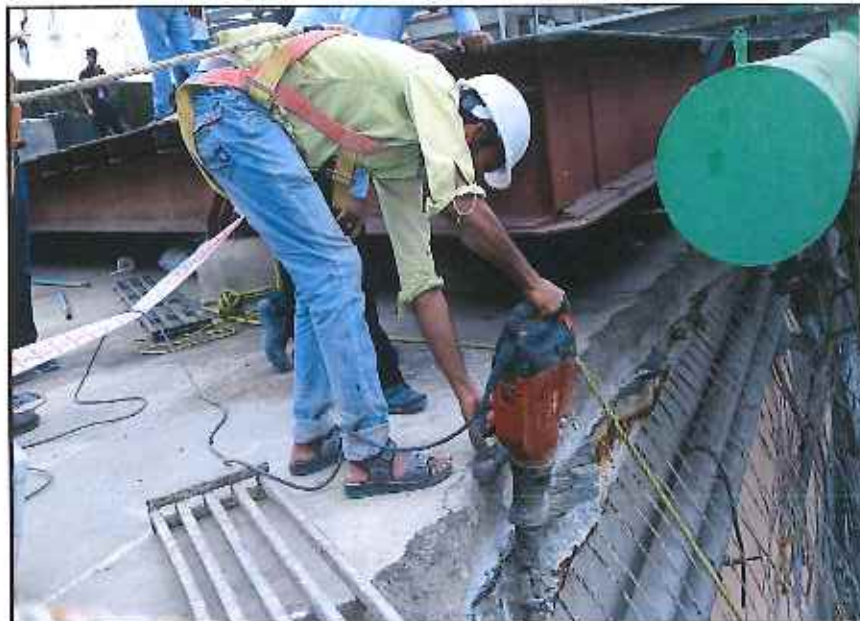
Ph. 15

Chipping of fractured surface at roof level to expose top bars

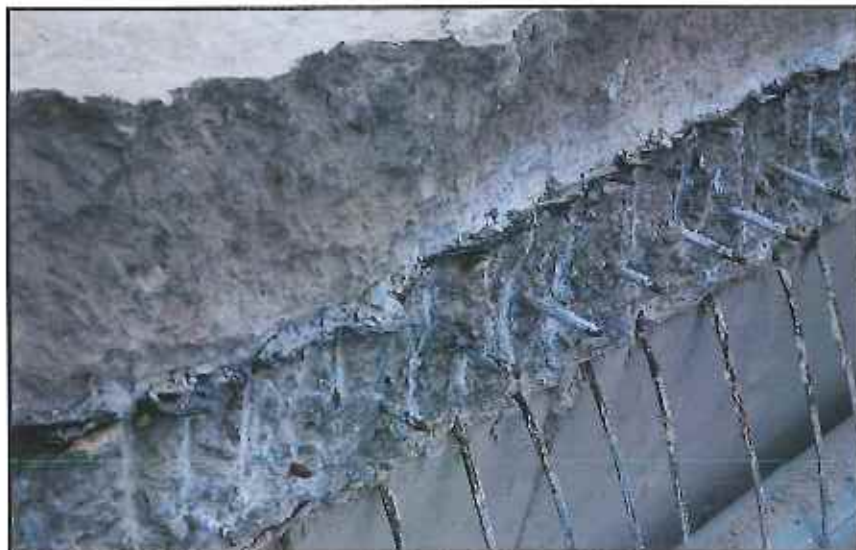
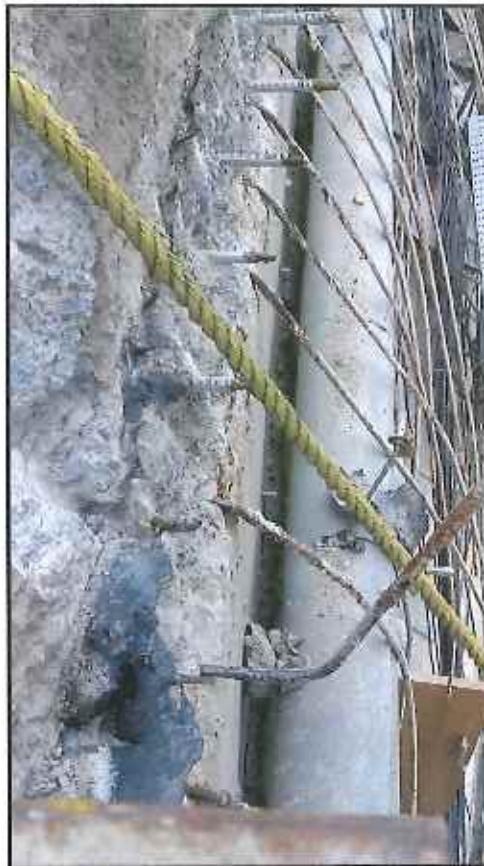
Ph. 18

**Snapped top bars of cantilever
(Typical views)**

10. The left over bars in the fractured region and the snapped bars indicate that the bars are corroded exhibiting brown patches and formation of scales.

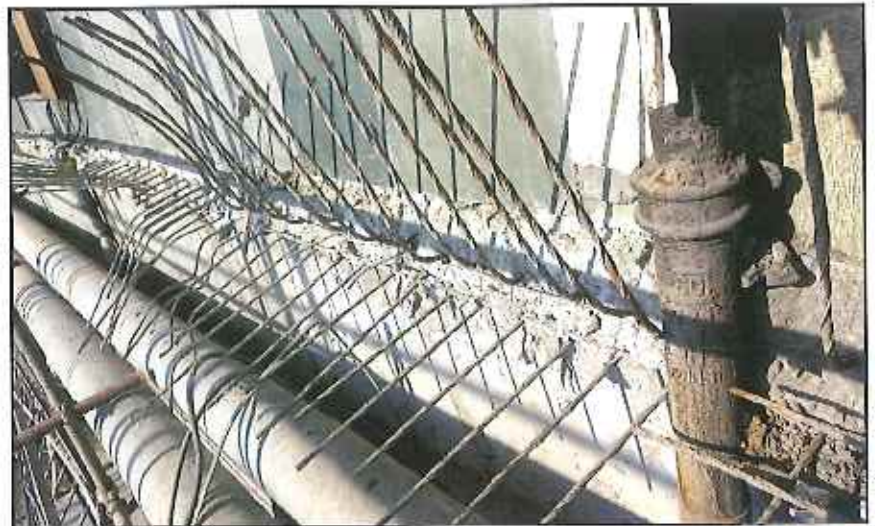
Ph. 25

**Disposition of bars in
fractured surface of
cantilever slab of
third floor
(top bars in mid region)**

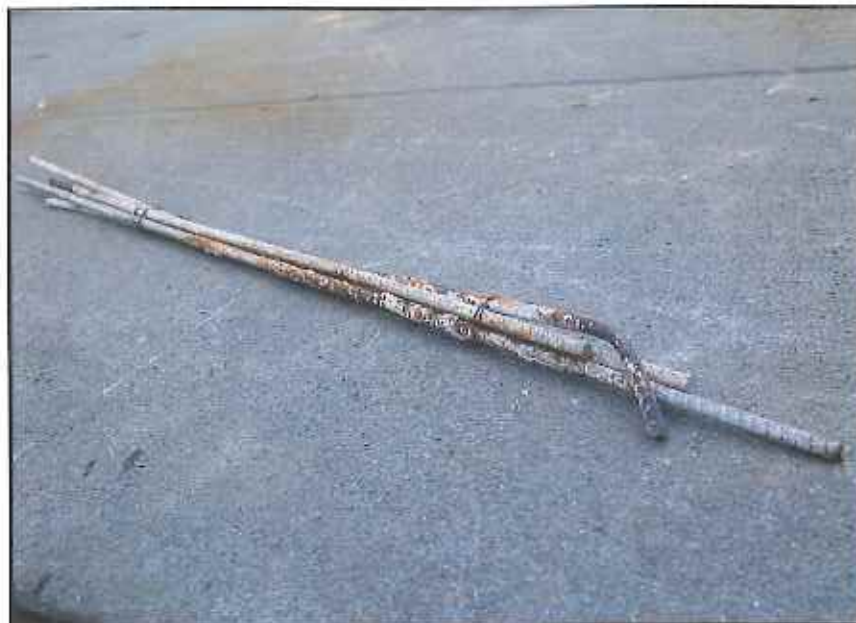
Ph. 31

**Collection of bottom reinforcement of
cantilever slab for testing**

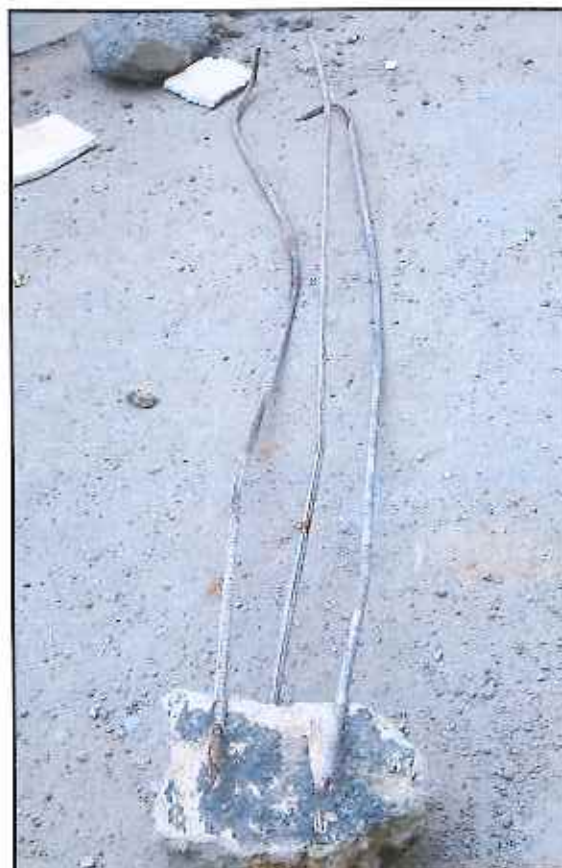
Ph. 32

**Top bars of collapsed cantilever roof slab
collected from debris**

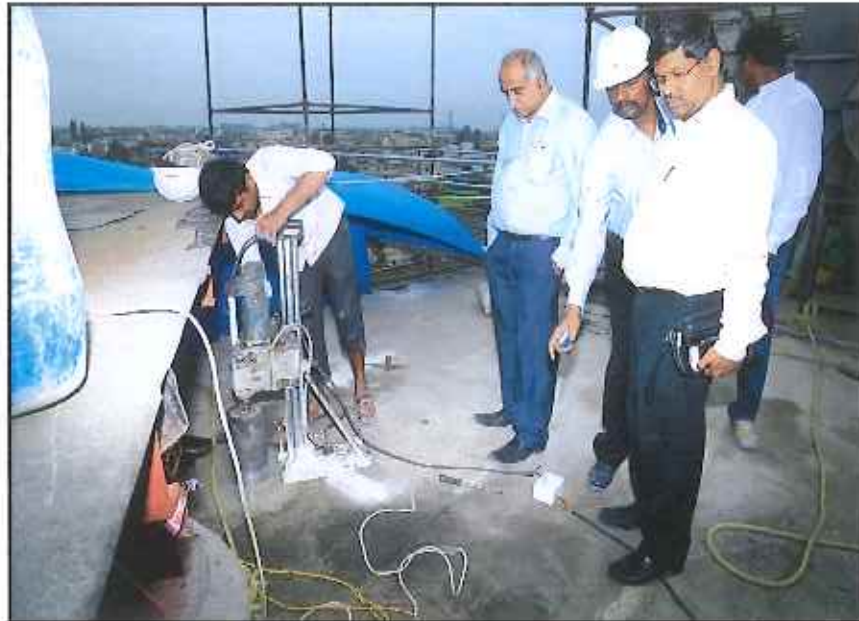
Ph. 33

Extraction of concrete core sample from RC slab in progress

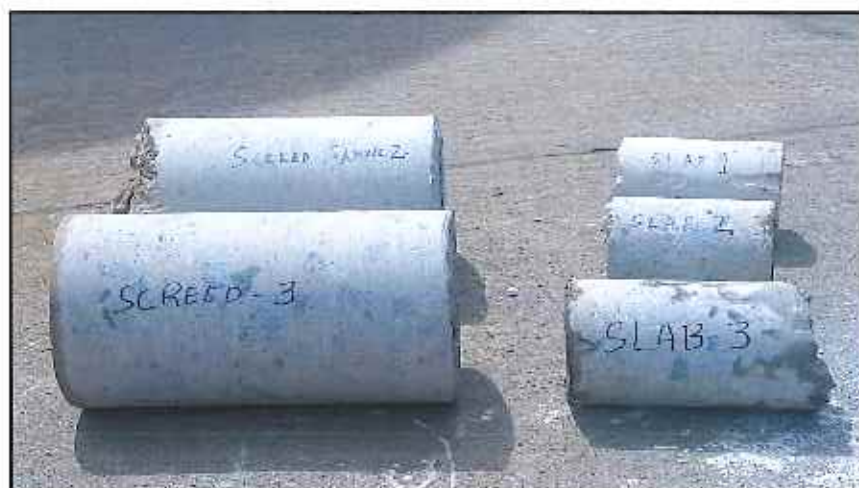
Ph. 34

View of extracted concrete core samples from screed and slab

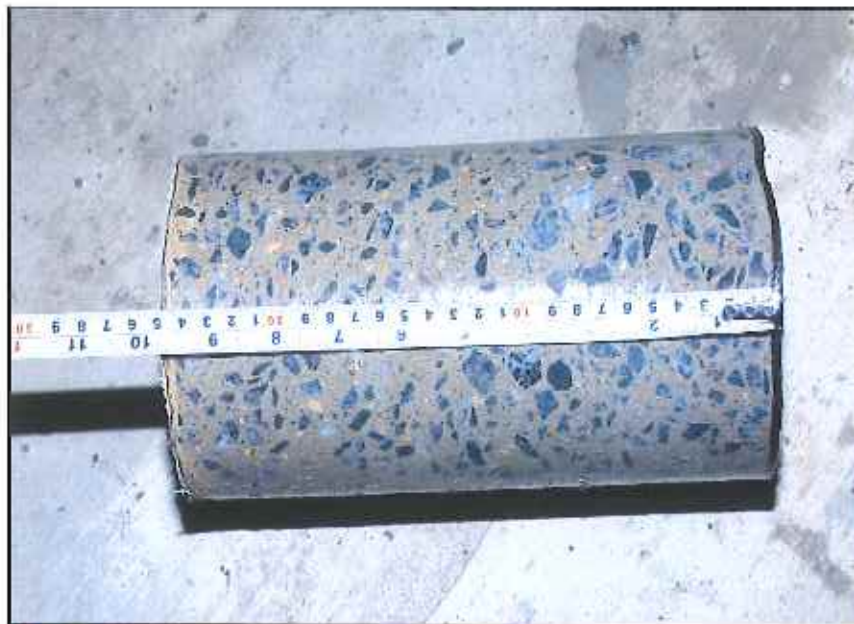
Ph. 35

Core from screed

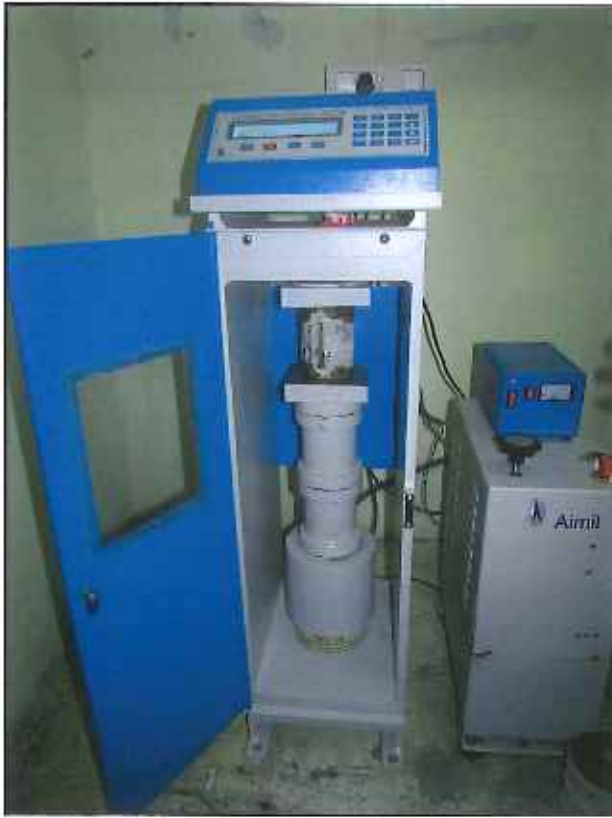
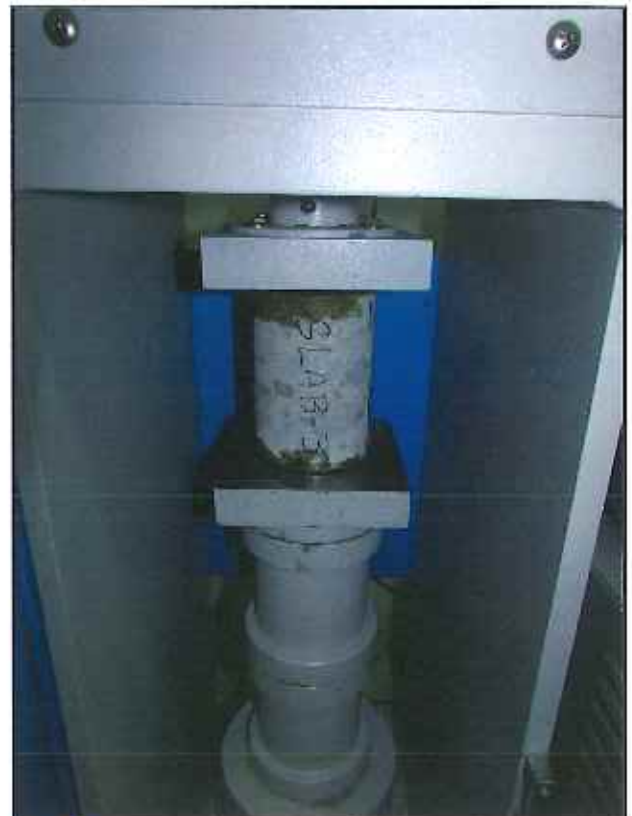
Ph. 37

**Views of core compressive strength
test in progress**

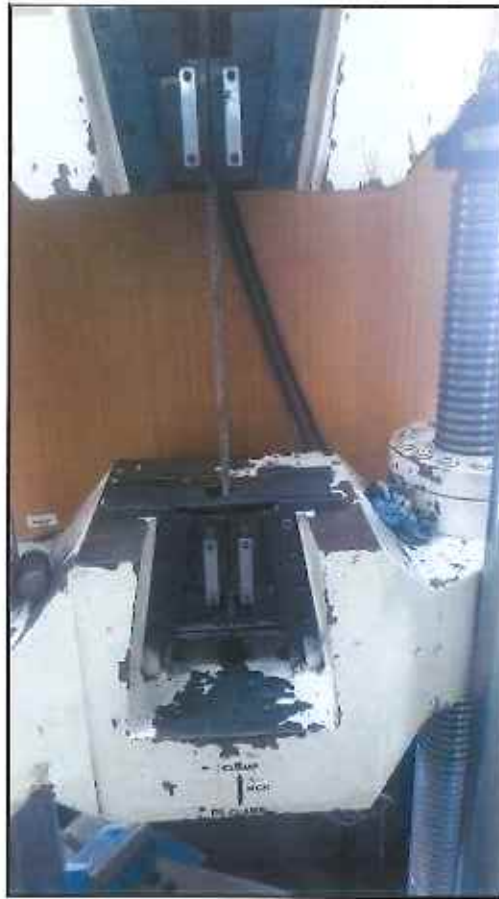
Ph. 39

Tensile testing of reinforcing steel

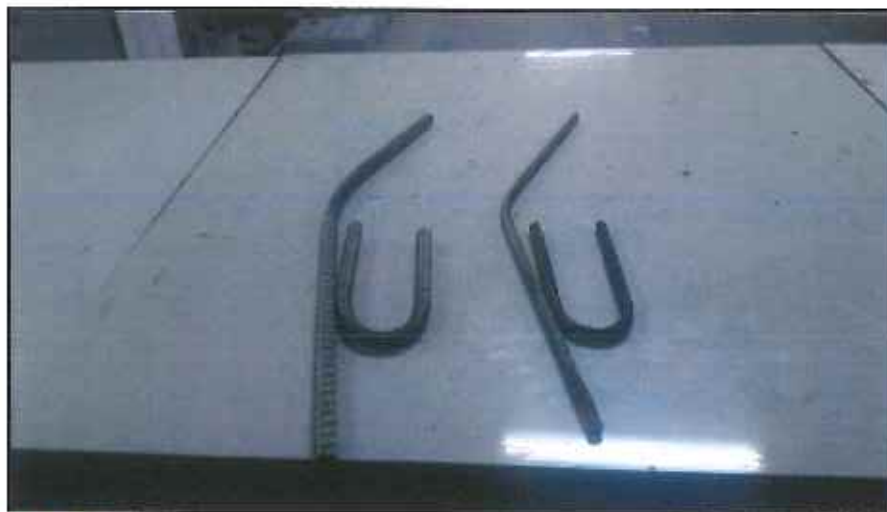
Ph. 40

Bend and Rebend test

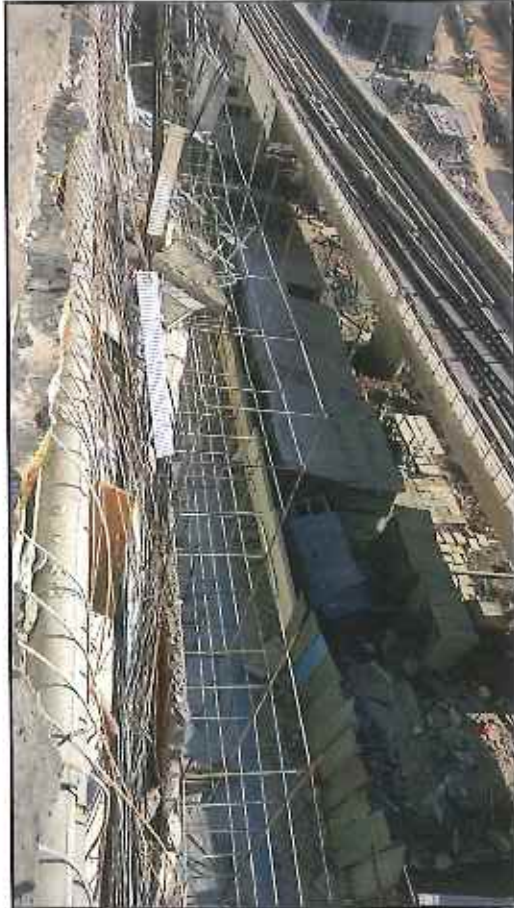
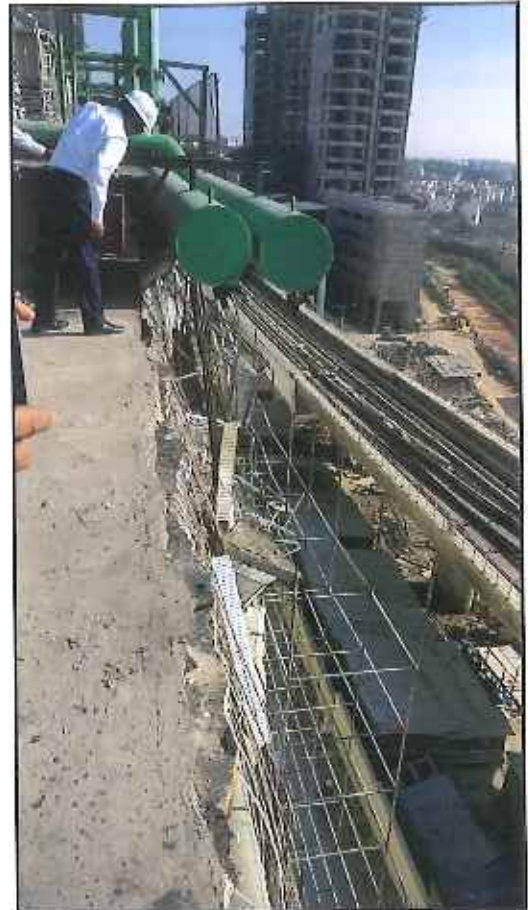
Ph. 05

Top view of collapsed cantilever roof slab

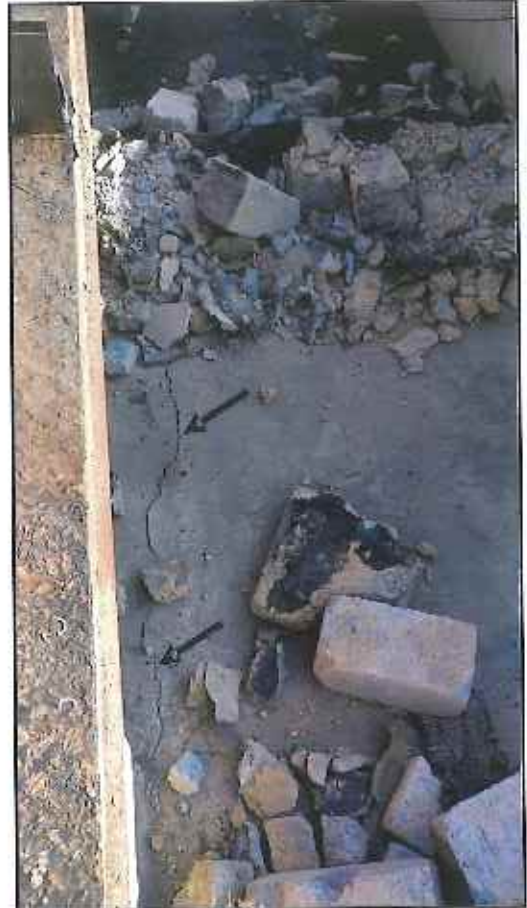
Ph. 07

**Crack in the cantilever
(Cantilever portion of roof slab
near collapsed region)**

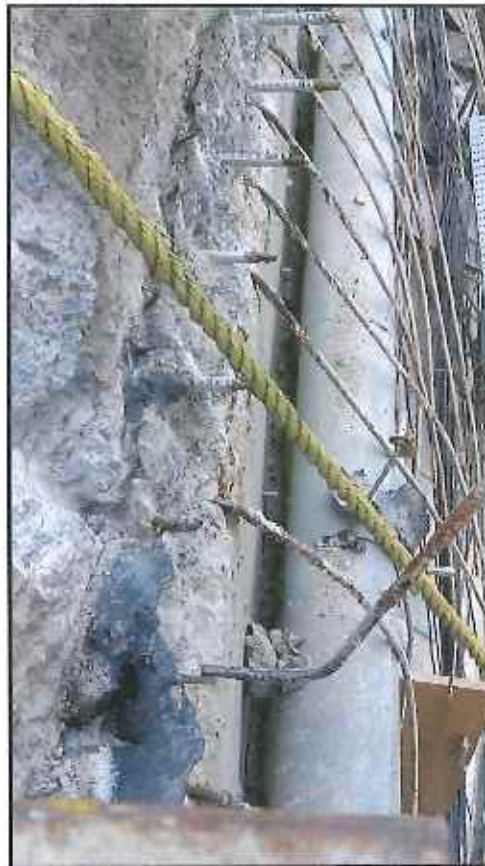
Ph. 18

**Snapped top bars of cantilever
(Typical views)**

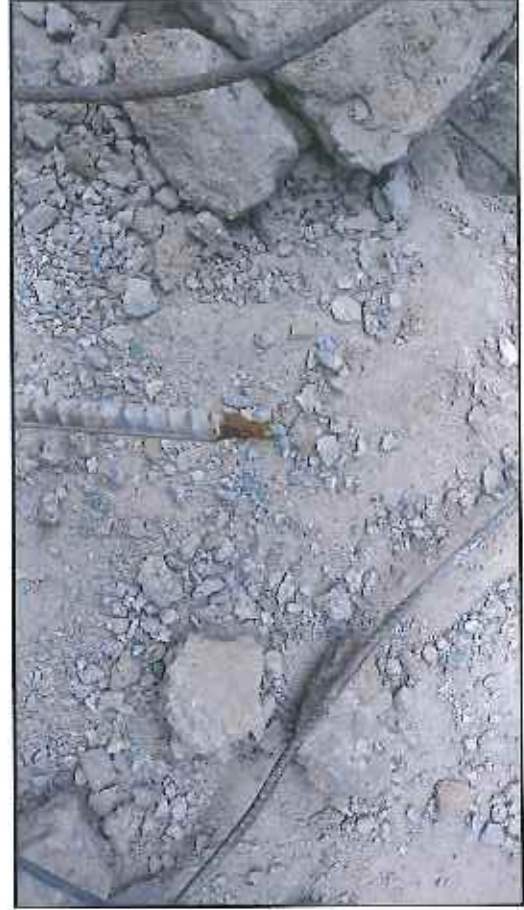
Ph. 23

**Corroded snapped top rebar
of cantilever**

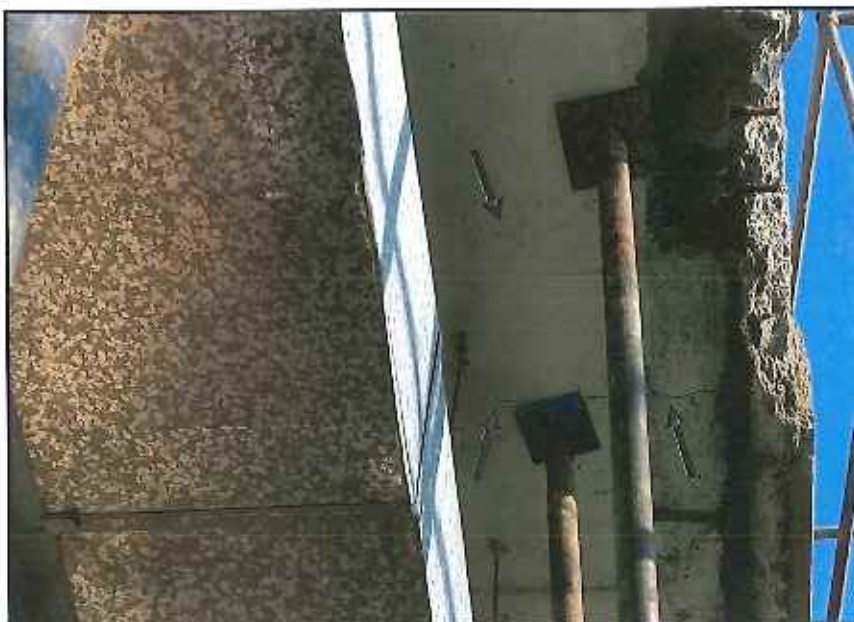
Ph. 26

**Cracks in cantilever
portion of roof slab**

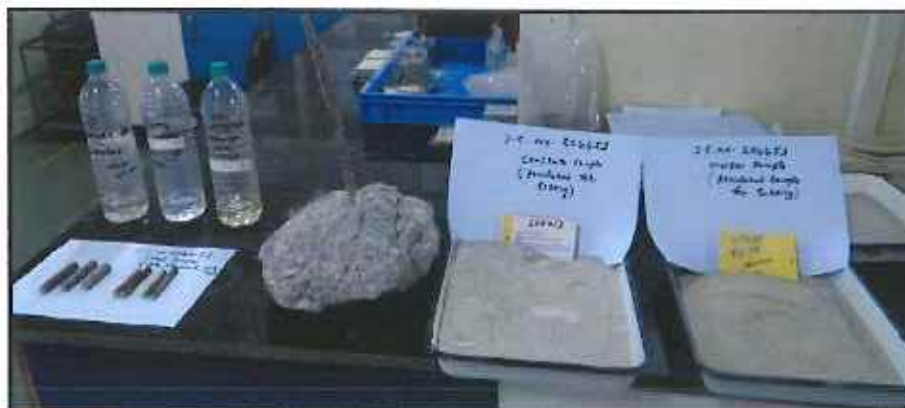
Ph. 36

Samples for testing

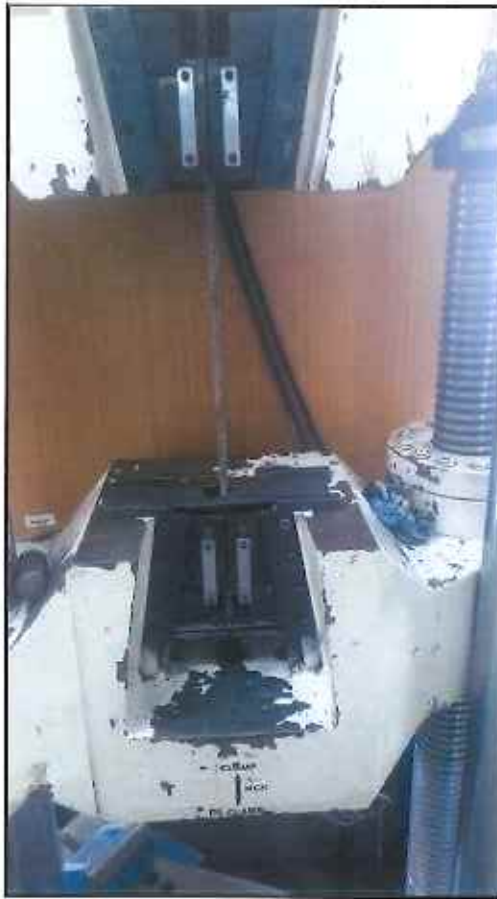
Ph. 39

Tensile testing of reinforcing steel
